# **Muskwa Kechika Joint Project**

**Teck Cominco Limited  
Ministry of Sustainable Resource Development**

## **2004 Work Summary and Churchill Copper Mine Reclamation Completion Report**

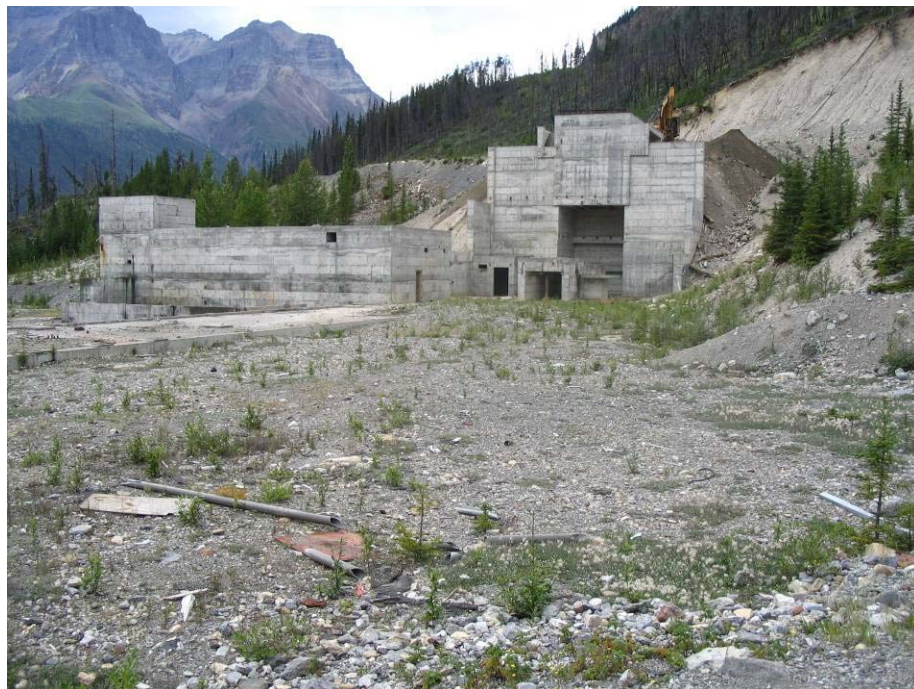
Durable concrete foundations were found at the crusher, mill, load out and maintenance structures. The concrete is in remarkably good condition but some exposed reinforcing bar was observed (photo 1).

**1-General Appearance of Mill Site Before Reclamation**

All Mill Site building foundation slabs and short walls were covered with soil. The reclaimed areas were seeded and fertilized (photo 2 and 3).

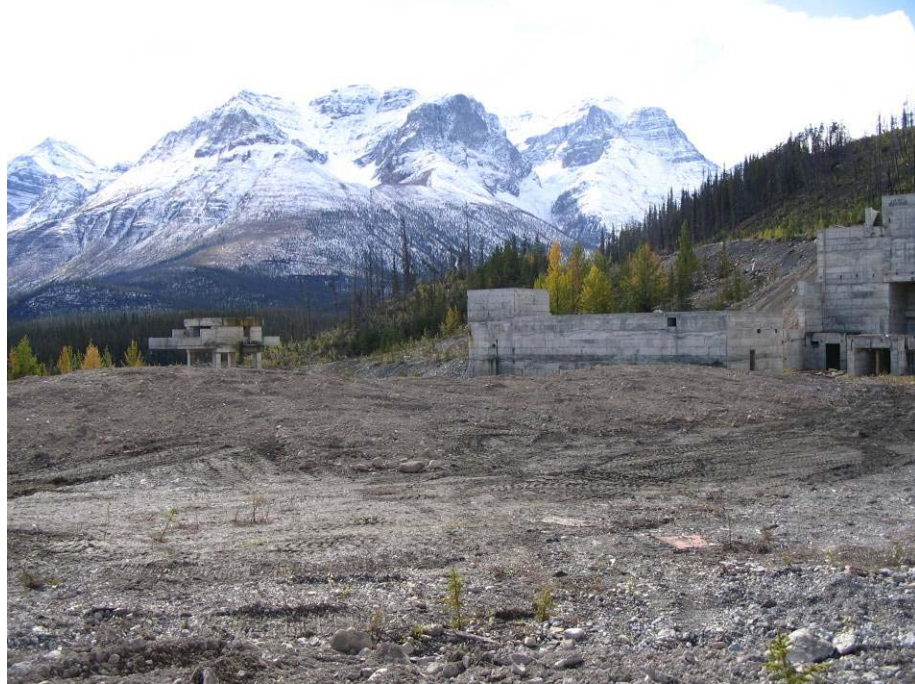
**2- Mill Site After Site Preparation**

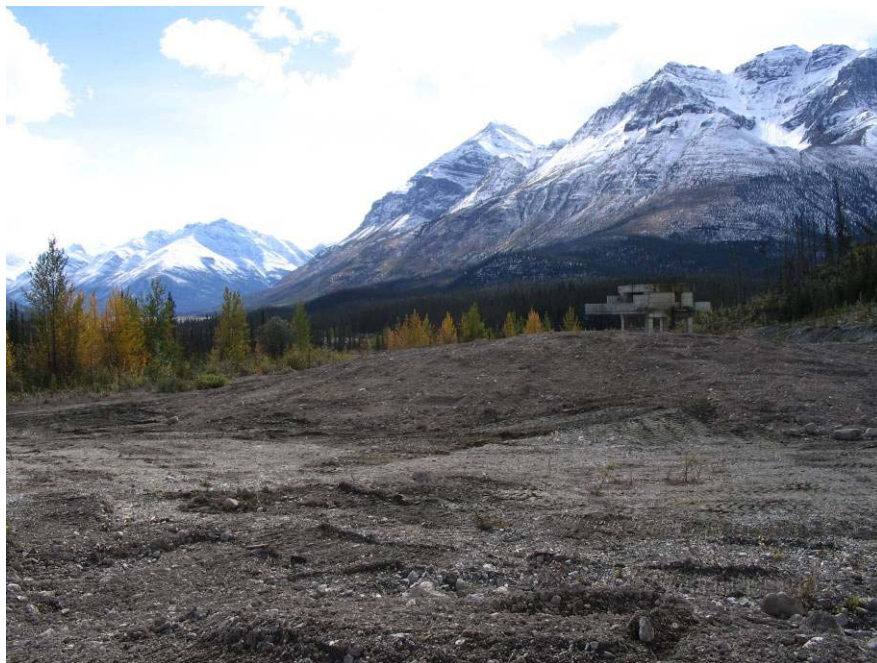
**3- Mill Site After Site Preparation - looking south**

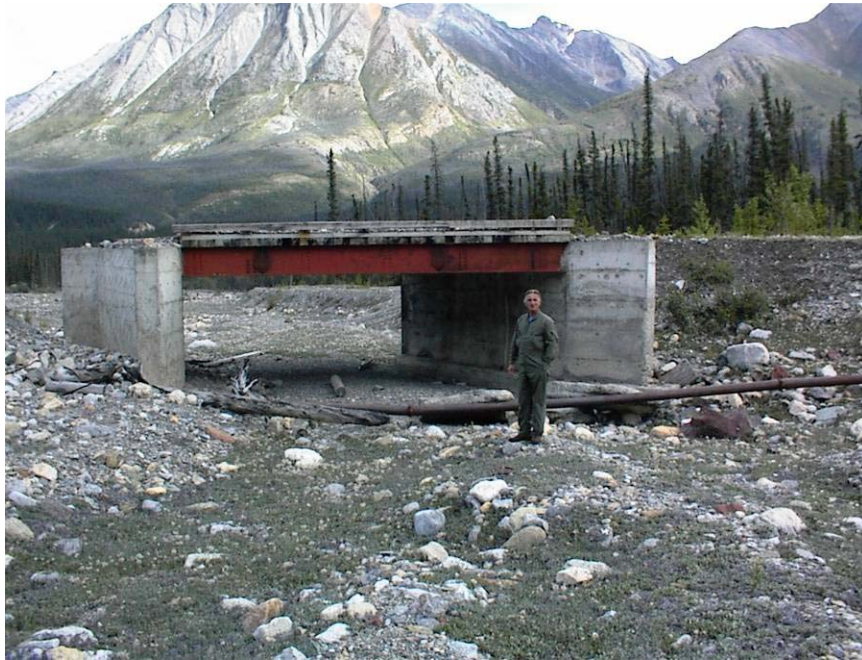
A bridge originally crossed a creek flowing from the north side of the Mill Site area. This creek has been naturally redirected to a new channel to the north of the site.

**4 - Bridge at Mill Site (2002) - looking east**

The bridge was demolished and the steel beams buried at the Mill Site Landfill (see section 8, Landfills). The bridge piers were pushed over and buried at the site (photo 5).

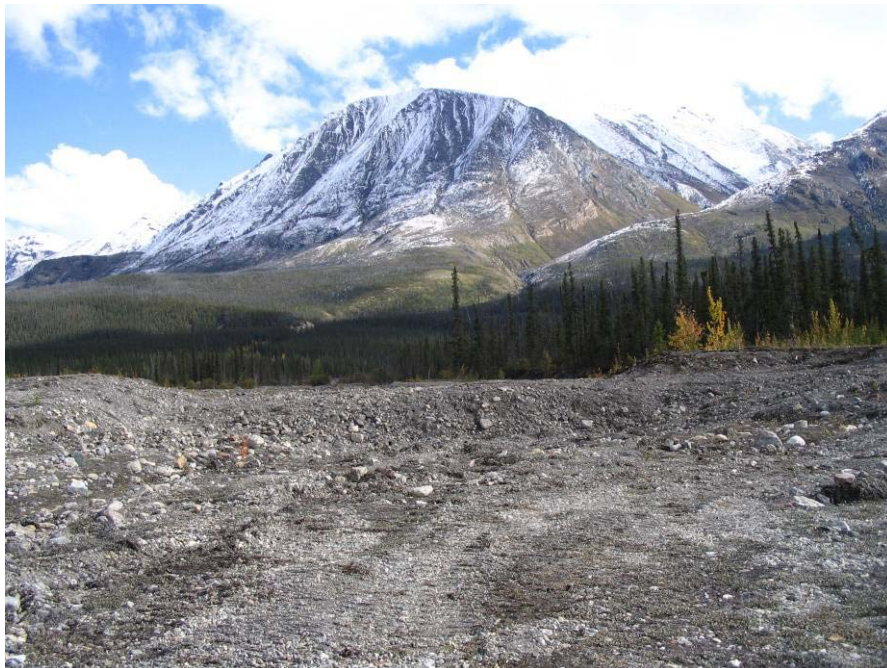
**5 - Mill Site Bridge After Reclamation - looking east**

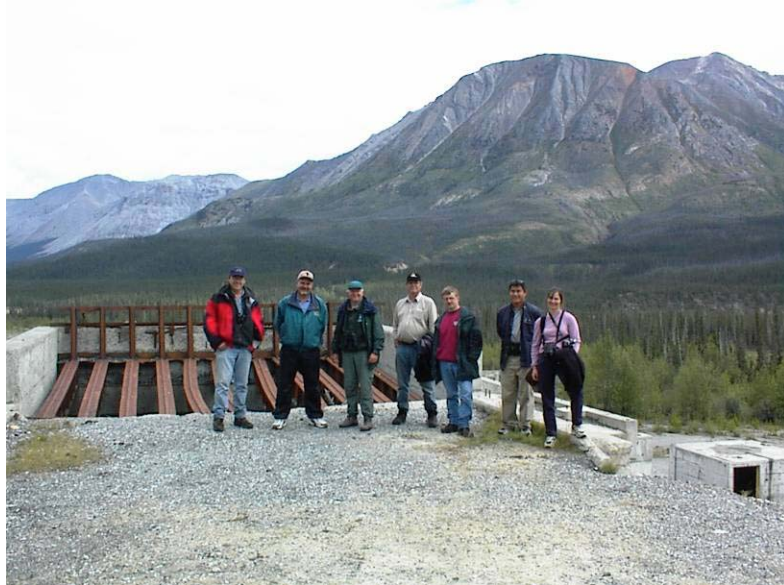
The ore truck dump feeder that includes a metal grizzly was built against a hillside. This structure has several floors. The truck dump apron adjacent to the grizzly was backfilled with rock after the crusher building was constructed (photo 6).

**6 - Ore Grizzly At Mill Site Looking East (2002)**

The approach to the Grizzly was excavated to a depth of 12 feet. No access top of the grizzly is possible (photo 7).

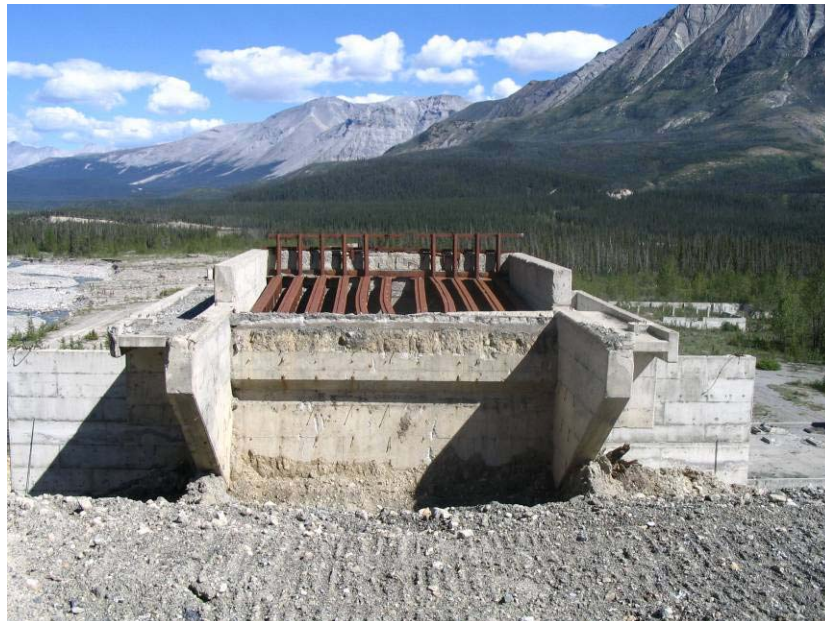
**7 - Grizzly After Excavating Approach**

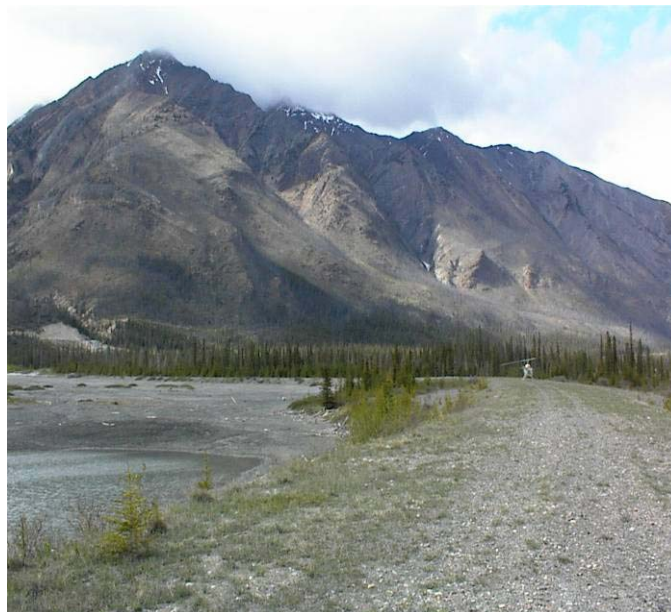
**8 - North Saddle Dam**

The second tailings pond is located southeast of the mill site (photo 8). The embankment is in good shape. The pond is well used by ungulates and provides grazing and hiding cover. .

A geotechnical investigation of the south tailings dams by Harder Associates of Ft. St. John, B.C. was undertaken in August 2004. Mr. Edward A. Wilson, P.Eng concluded that the tailings area required the removal and burial of a wood skimmer structure. As well as exposing and backfill of the discharge culvert associated with skimmer and resloping to 2.5:1 around the backfilled area. All the above work was carried out under the supervision of Mr. Wilson. The geotechnical report signed by Mr. Ian H Harder, P.Eng., can be found in Appendix D.

A Geotechnical Investigation Report by Harder Associates Ltd. concluded that a culvert through the North Saddle Dam required plugging. This work was carried out with the supervision of a Professional Engineer.

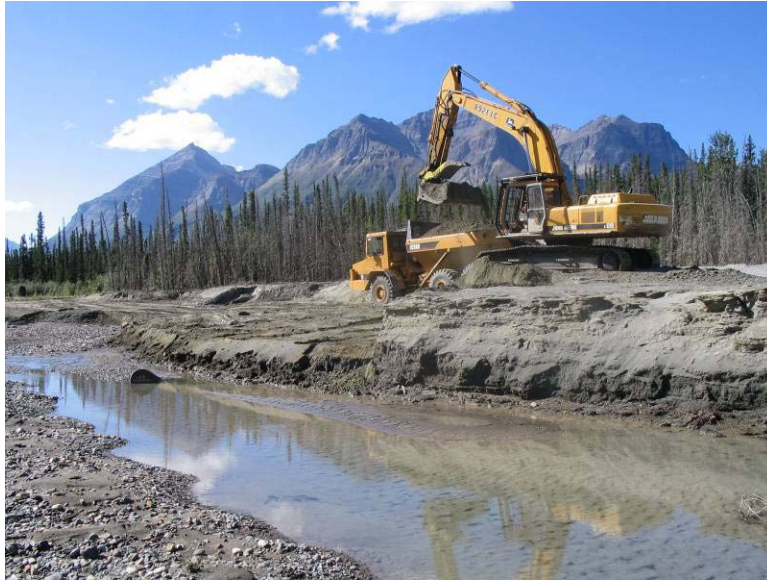
**9 - Loading Sand From North Tailings Area**

Approximately 5,000 cubic meters of sand from the north tailings area were hauled out of the flood plain. The sands were excavated down to the organic layer underlying the material (photo 9 and 10). The remaining sands

were resloped and the slope armoured with coarse gravel. The excavated area was seeded to stabilize the slope.

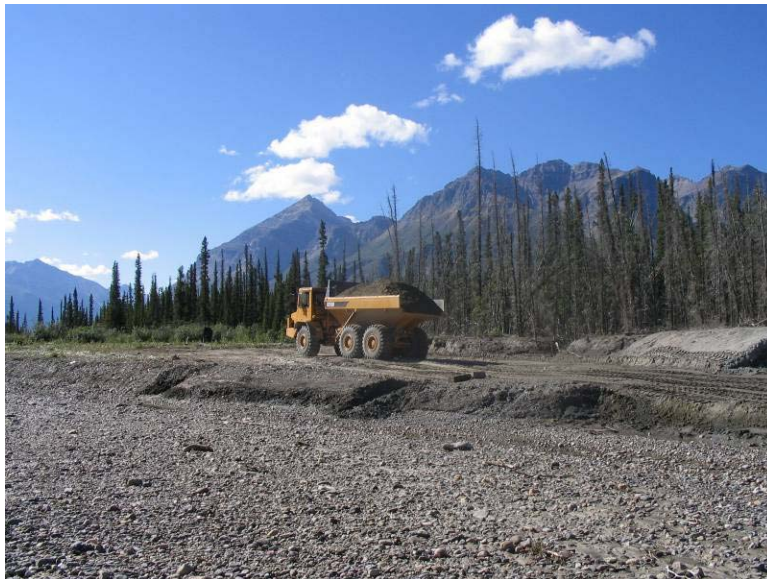
**10 - Sand Hauling Out Of Flood Plain**

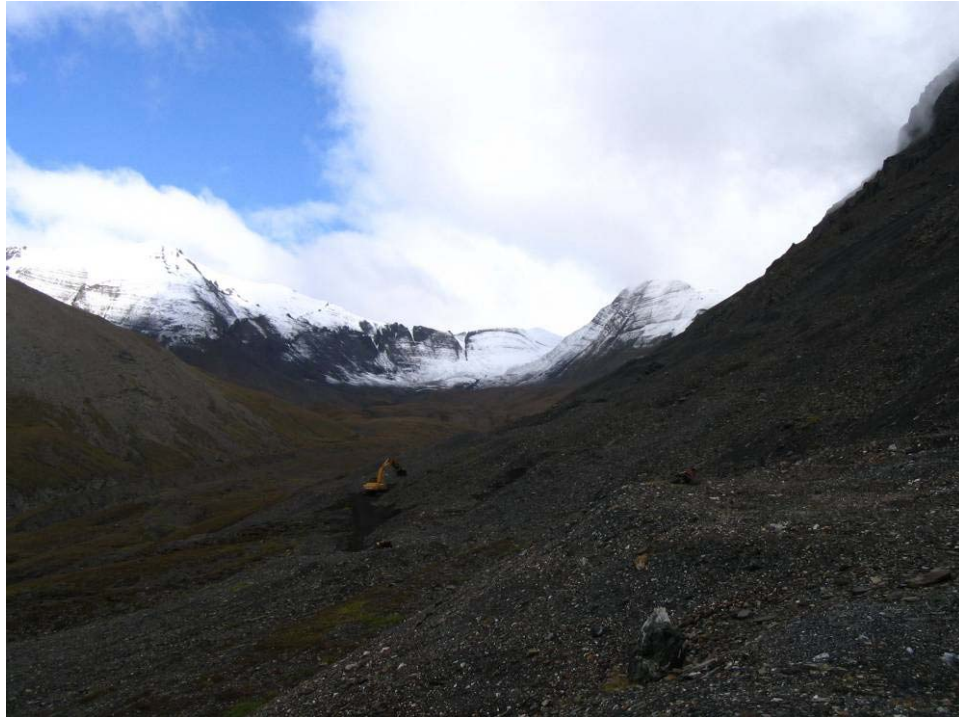
The road to the mine adits approximately 21 kilometers from the mill required significant clearing to allow passage of heavy equipment (photo 11). Numerous washouts and a small abandoned bridge were found along the route.

### 11 - Hoe Building Road To Upper Alpine Mining Area

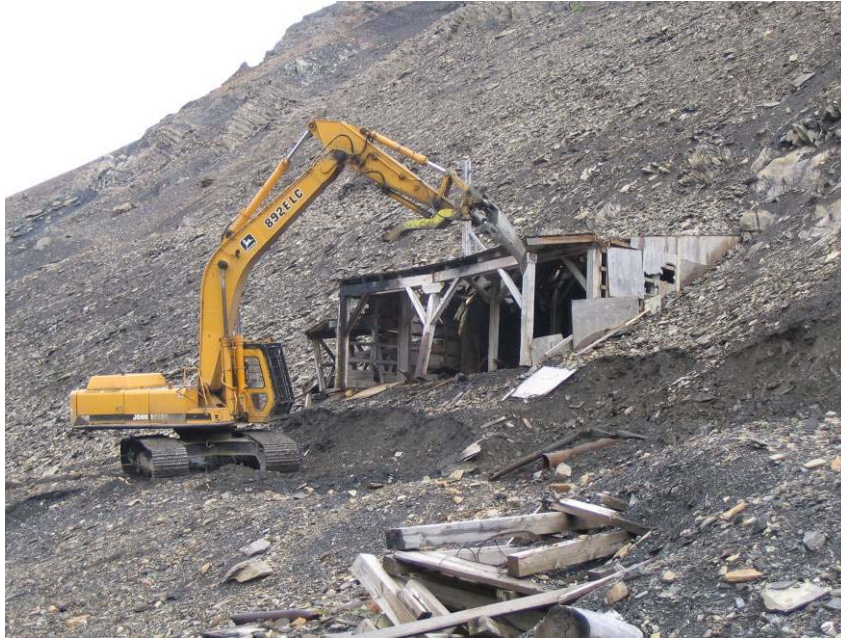
**12 - Hoe Demolishing Wooden Entrance To Adit 1**

The remaining upper alpine adits were plugged using heavy equipment. Wood and steel refuse were placed with the adit. The adits were closed with coarse rock and resloped (photos 12-15).

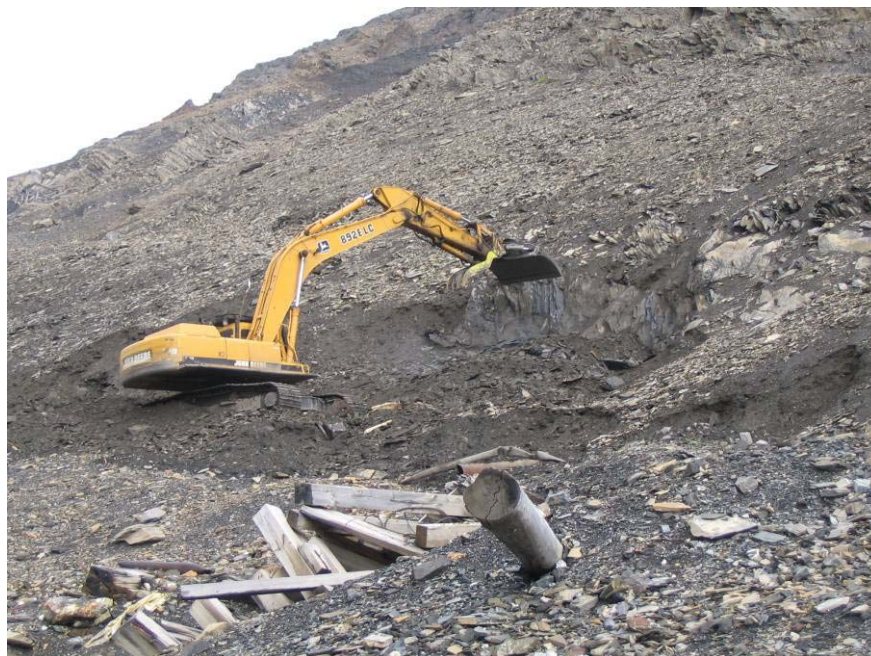
**13 - Sealed Adit 1**

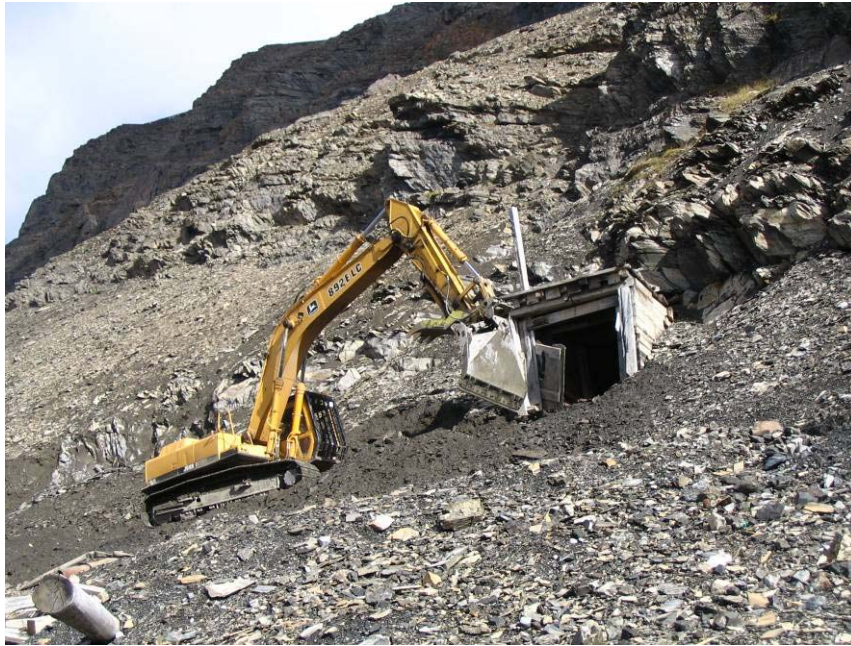
**14 - Mine Adit 2 Before**

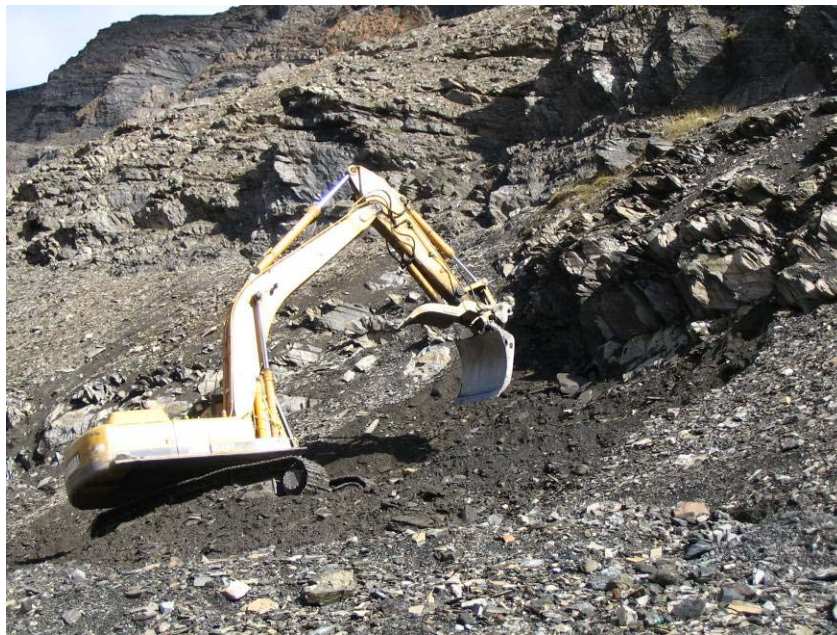
**15 - Adit 2 Sealed**

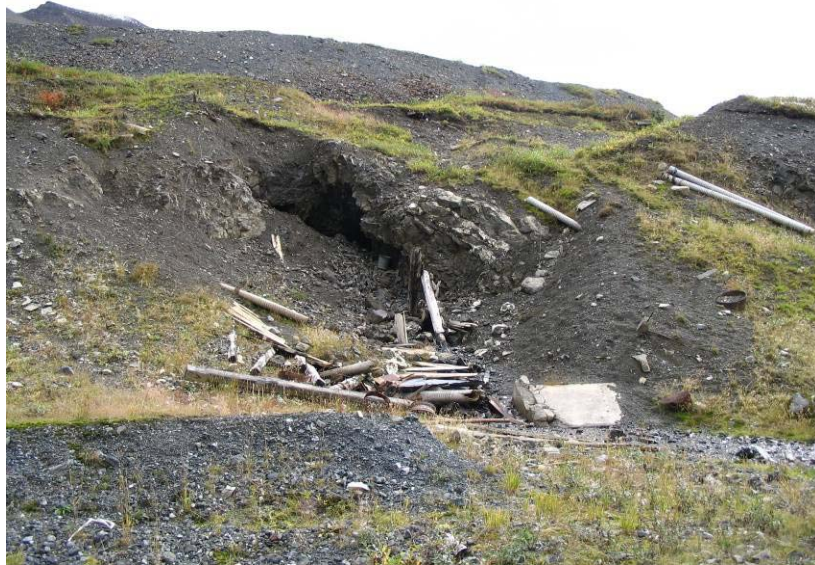
**16 - Adit 3 Below Mine Building Area**

The two (2) adits found at the mine building site were sealed (photos 16 and 17). All wooden refuse found around the area was placed in the adit before sealing with coarse rock. These areas were seeded and fertilized.

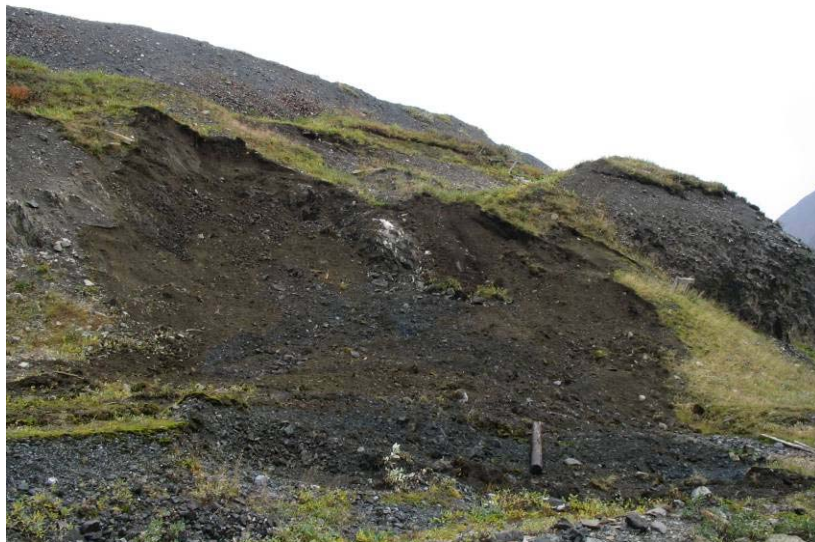
**17 - Adit 3 Sealed**

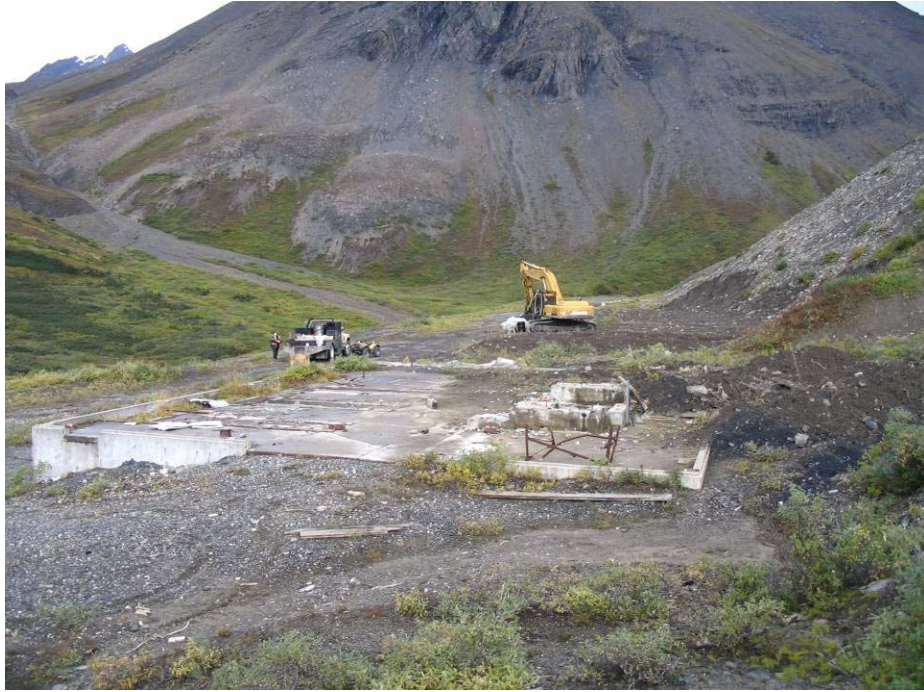
**18 - Mine Building Foundations**

Mine building foundation slabs were found exposed (photo 18). The slabs were covered with soil (photo 19). The areas were seeded and fertilized.

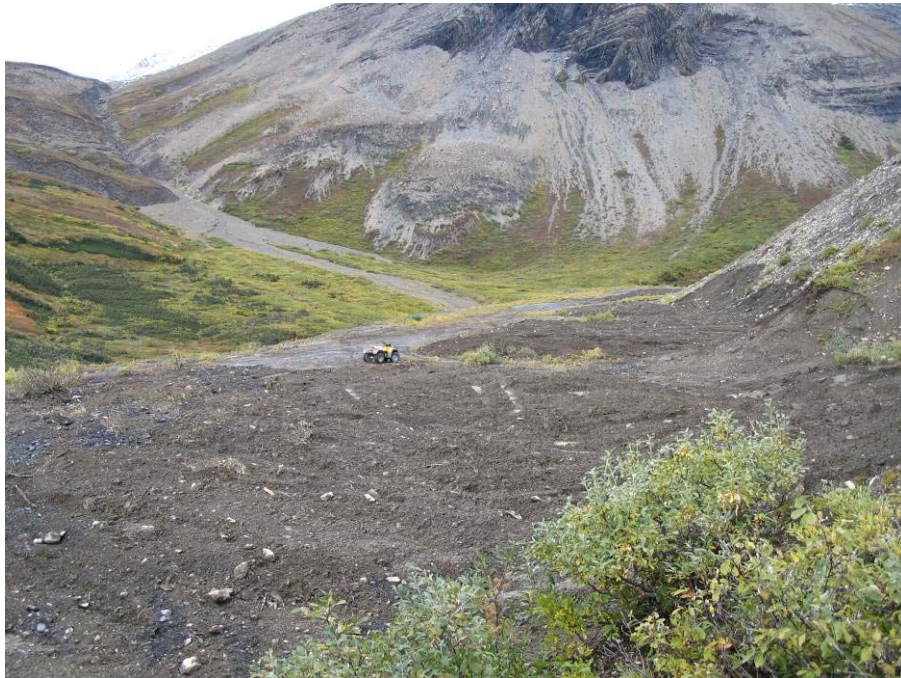
**19 - Building Foundations Covered With Soil**

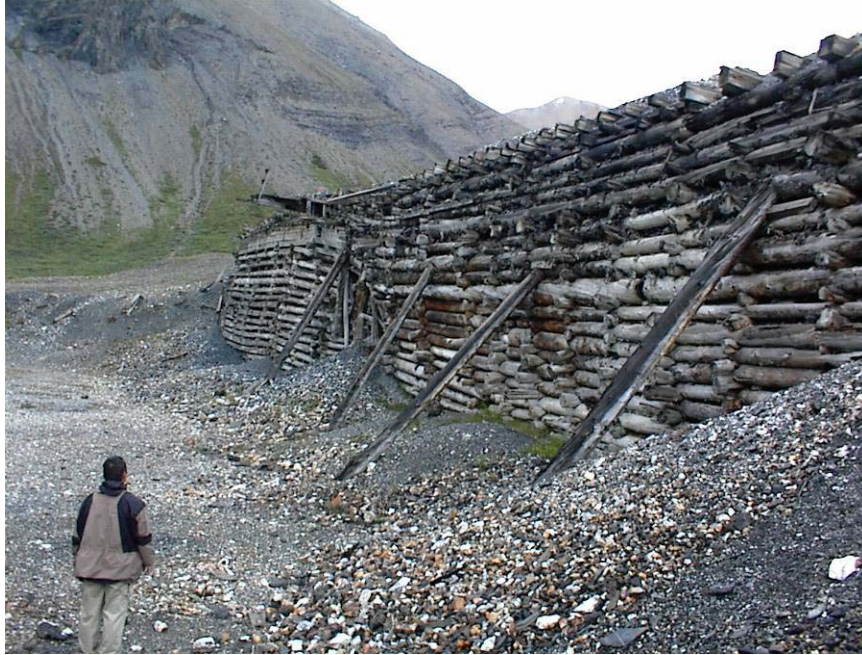
**20 - Wooden Cribbed Wall At Mine Site**

A cribbed log wall was found at the mine building site (photo 20). This structure was demolished and covered with soil. The sloped area was seeded and fertilized (photo 21).

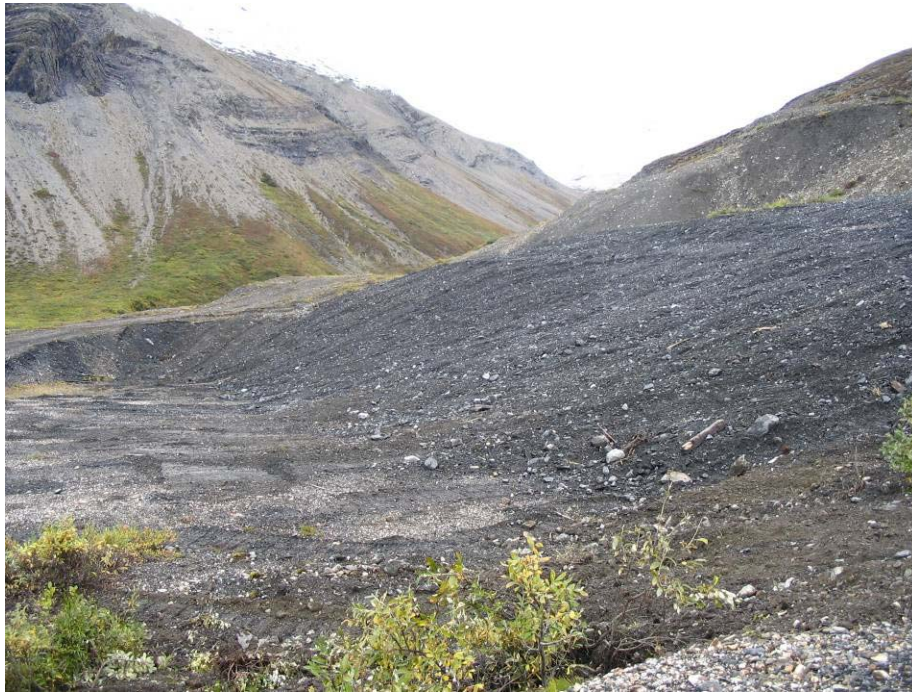
**21 - Wooden Cribbed Wall Area Contoured And Covered With Soil**

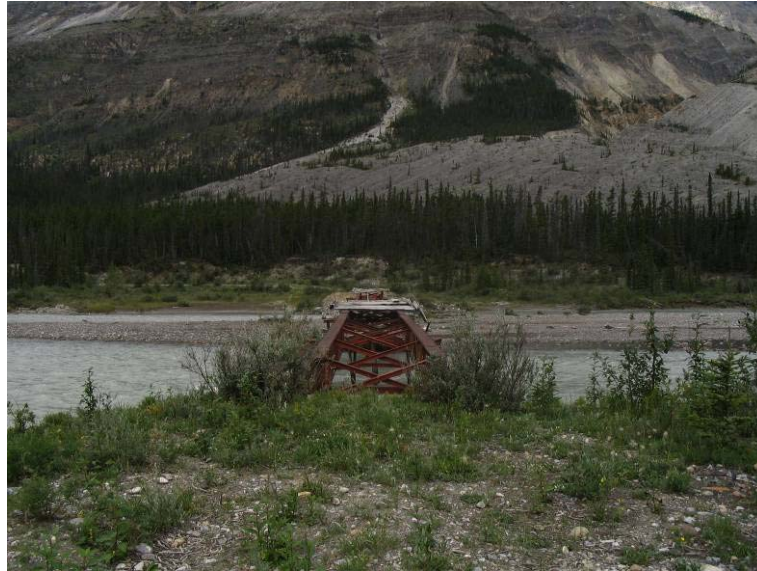
All approaches to the Racing River Bridge were completely eroded. The bridge piers, metal superstructure and wood decking were found to be in an advance state of deterioration but still standing (photo 22).

**22 - East Approach To Racing River Bridge**

It was necessary to reconstruct the approach to the east side to allow workers to get onto the bridge (photo23). The bridge was cut into manageable pieces to aid in the demolition (photo 24)

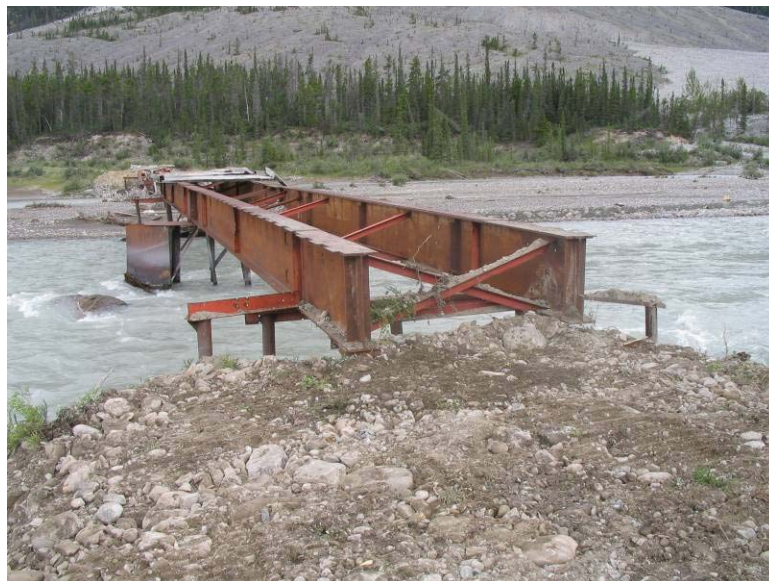
**23 – East Approach To Racing River After Re-Construction**

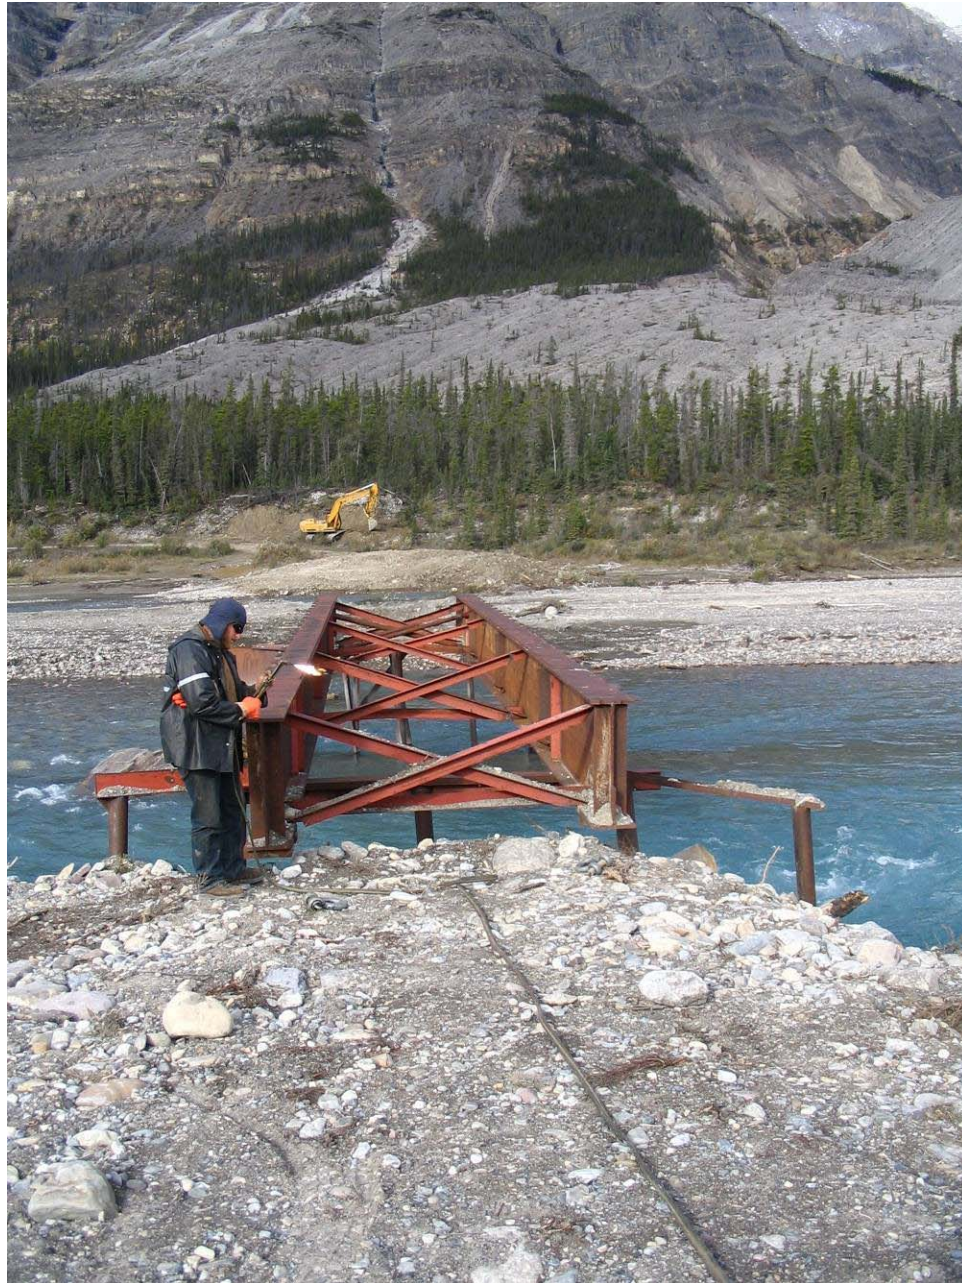
### **24 – Steel Cutting Racing River Bridge**

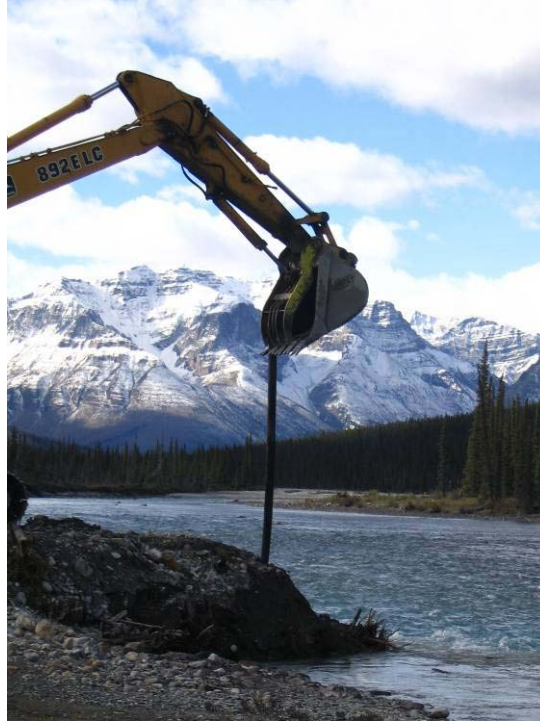
**25 - Removing Steel Pier From East Side Of Racing River Bridge**

After the beams and decking were removed from over the river channel, the steel pilings were removed with the aid of the backhoe (photo 25 and 26). The bridge was removed from the river with very little river bed disturbance. Most of the work was undertaken with the hoe positioned on the shore. Steel section and pilings removal was carried out using the long reach of the backhoe.

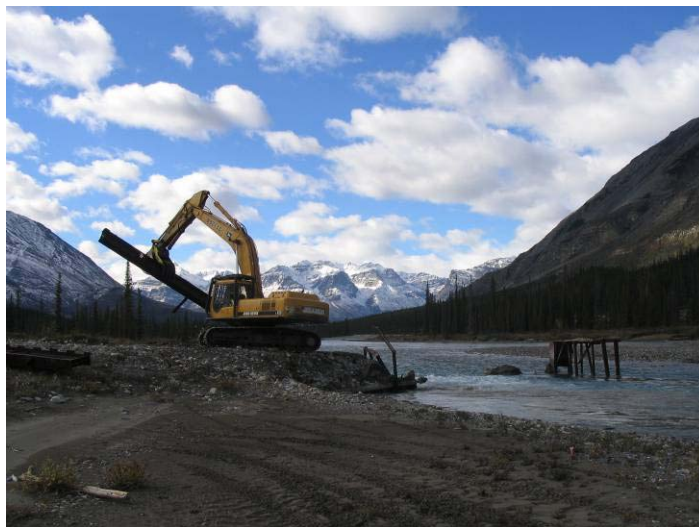
**26 - Removing Beam From Racing River Bridge**

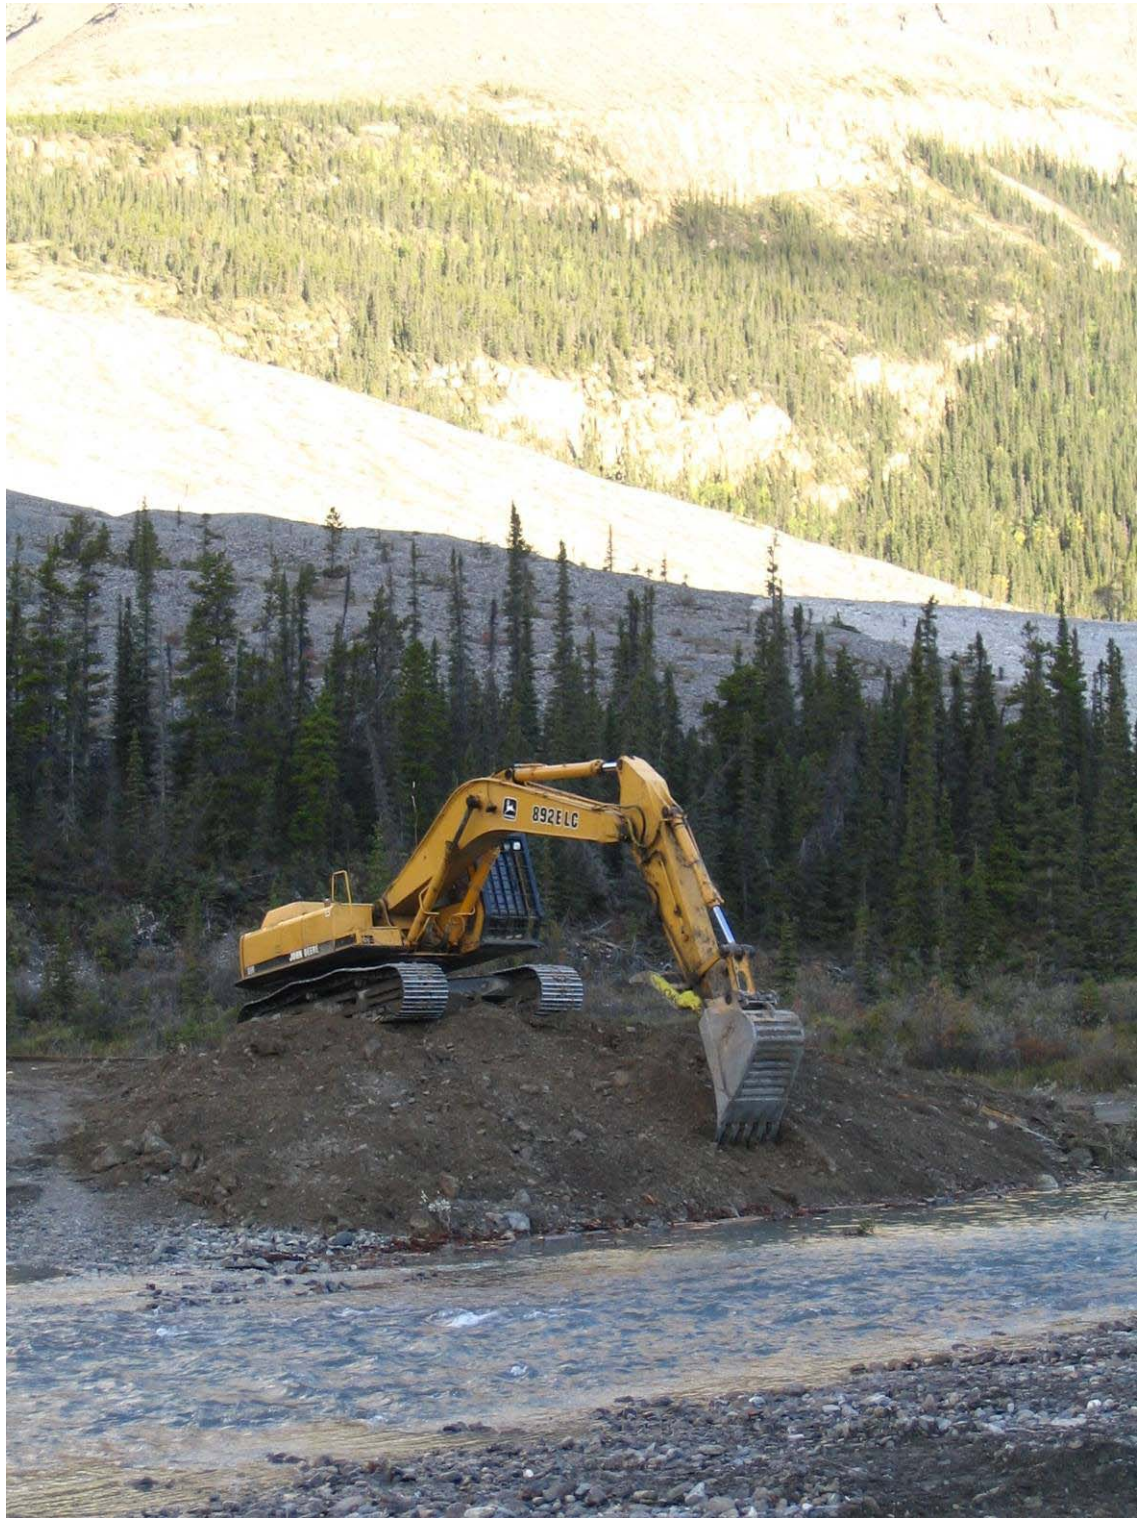
**27 - Contouring Racing River Western Approach**

Both approaches were resloped. Special care was taken to ensure that excavated material did not fall into the river (photo 27). The slope was seeded (photo 28). No fertilizer was applied within 100 feet of any water body.

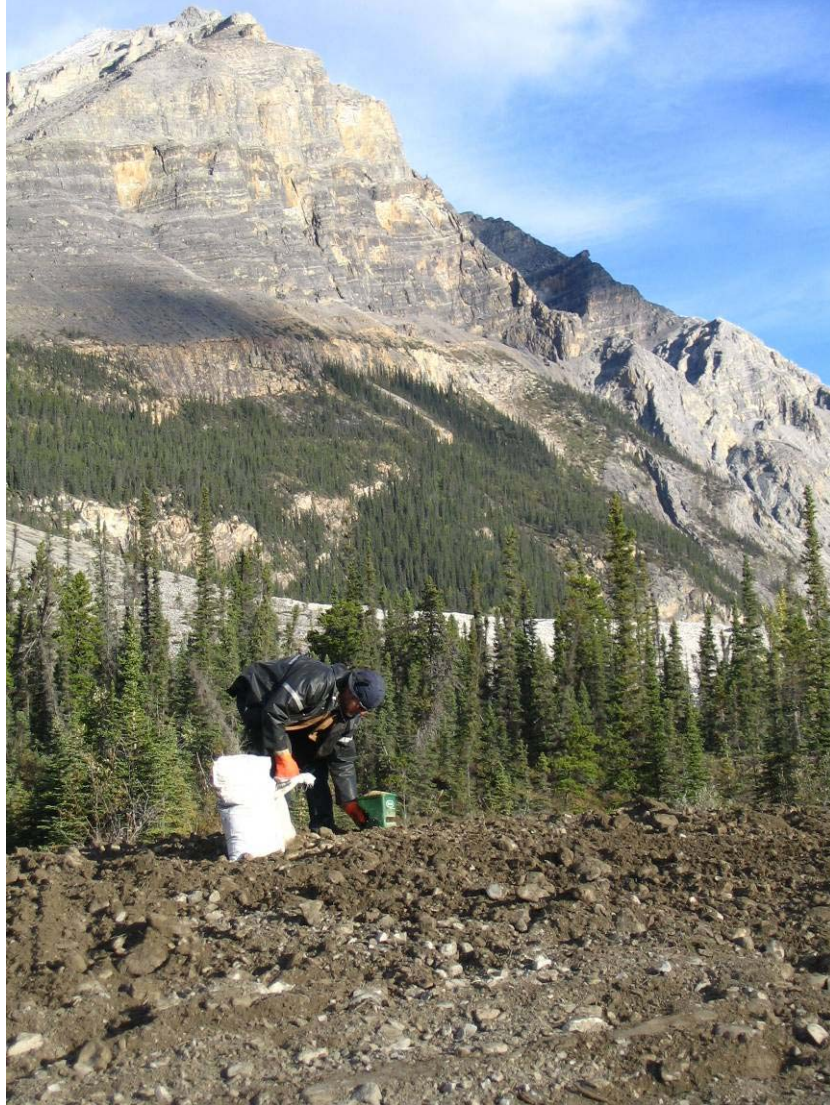
### **28 - Seeding Bridge Approaches**

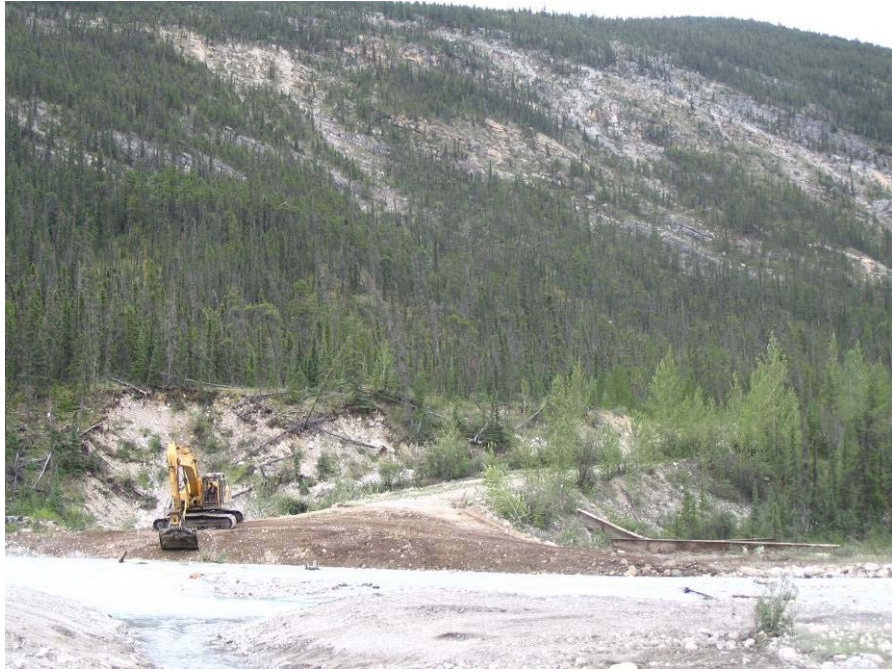
**29 - Contouring Wokkpush Creek Southern Approach**

The same method carried out on the Racing River, was used to reclaim the Wokkash and MacDonald Creek bridges and approaches (photos 29 and 30).

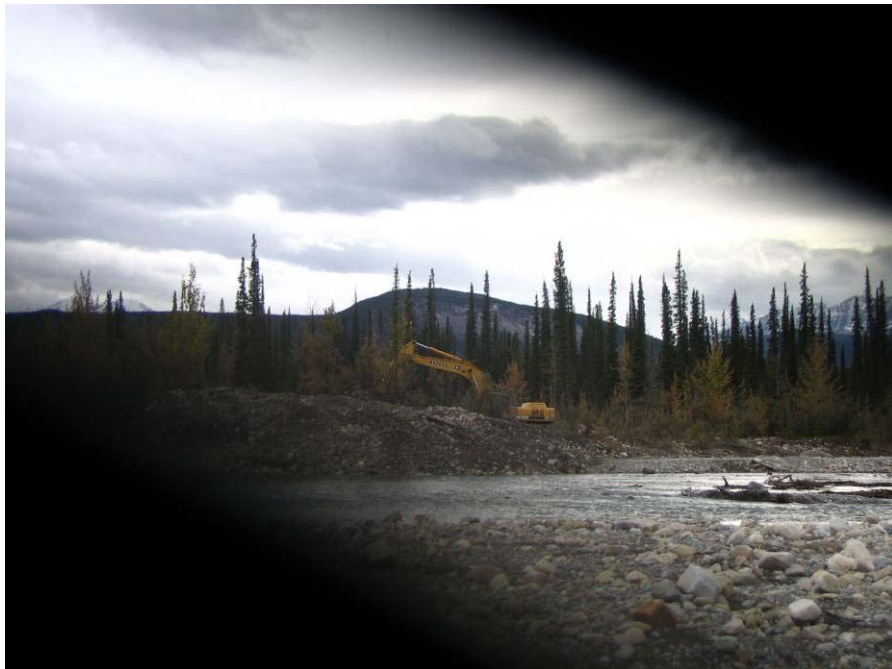
**30 - Contouring Macdonald Creek Southern Approach**

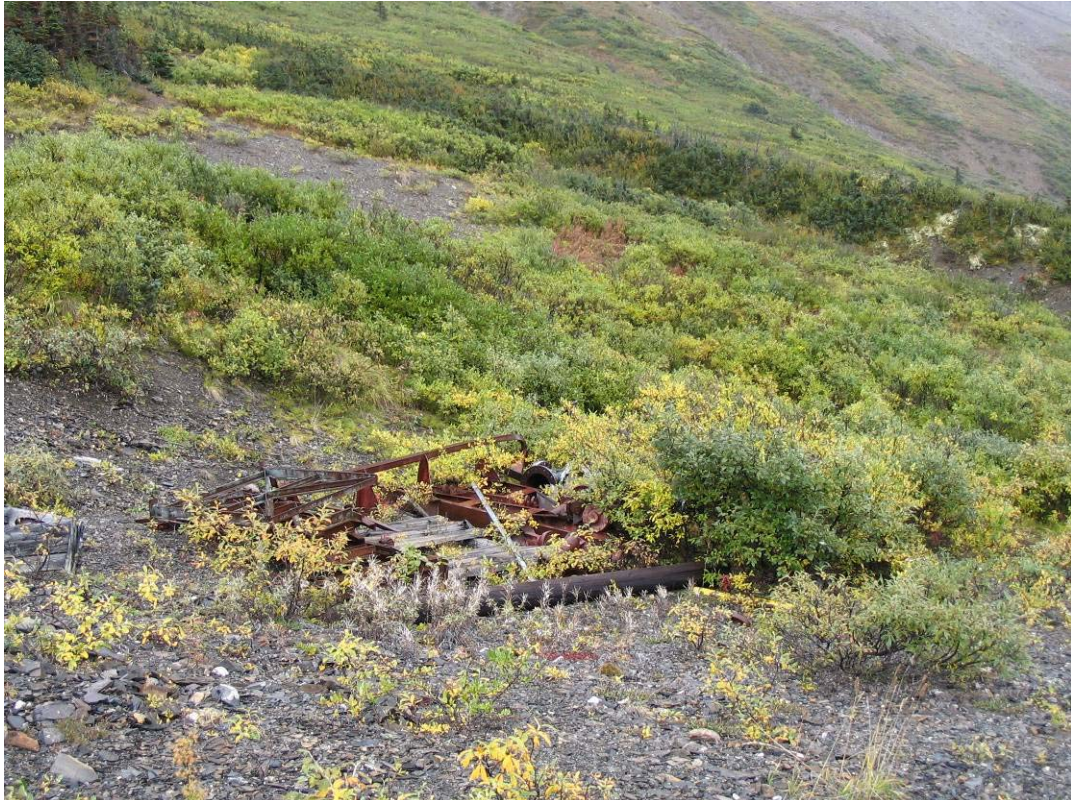
In 2001, an exposed refuse landfill was found near the southeast corner of the northerly tailings area. The land fill appears to be the source of incidental refuses found along the west shore of the Racing River such as metal pipe, newspaper, and plastic bags. In addition, metal refuse and underground mine cars were found at the Mine Site in the alpine (photo 31).

**31 - Mine Site Steel Refuse**

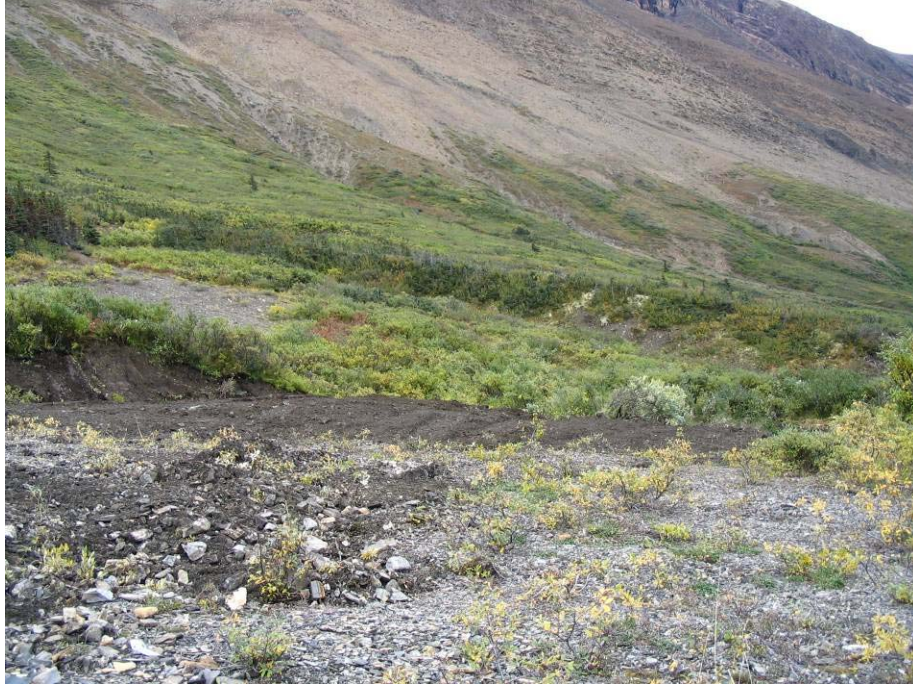
**32 – Reclaimed Mine Site Landfill**

A landfill was established near the mine building site. Any steel or wood was moved and deposited within the landfill. The landfill was covered with soil, seeded and fertilized (photo 32).

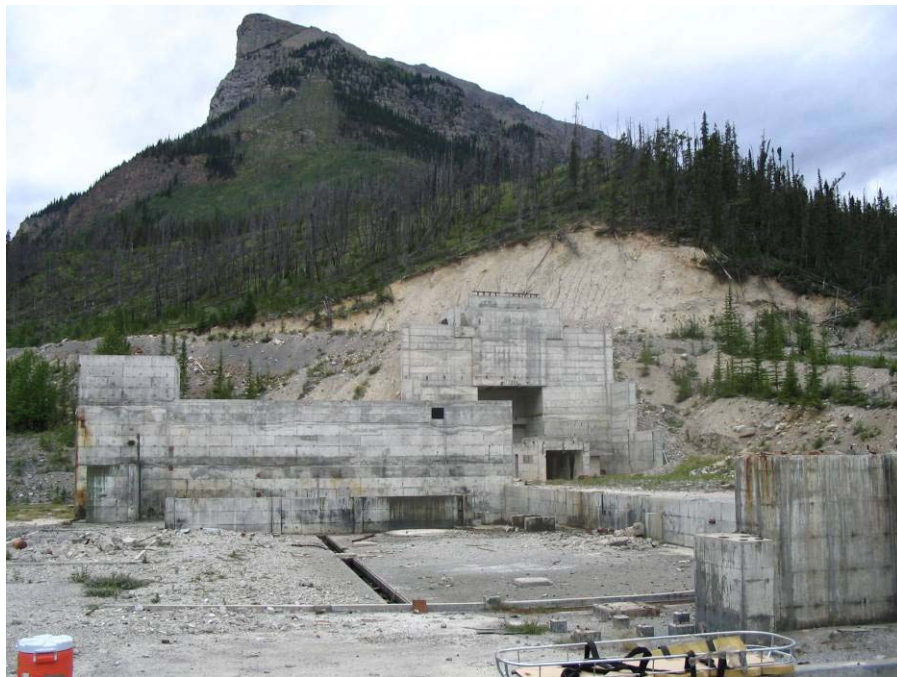
**33 - Mill Site Landfill Before Filling**

A second landfill was located in the foundation of the Mill building at the Mill Site (photo 33).
