# **Muskwa Kechika Joint Project**

**Teck Cominco Limited  
Ministry of Sustainable Resource Development**

## **2004 Work Summary and Churchill Copper Mine Reclamation Completion Report**

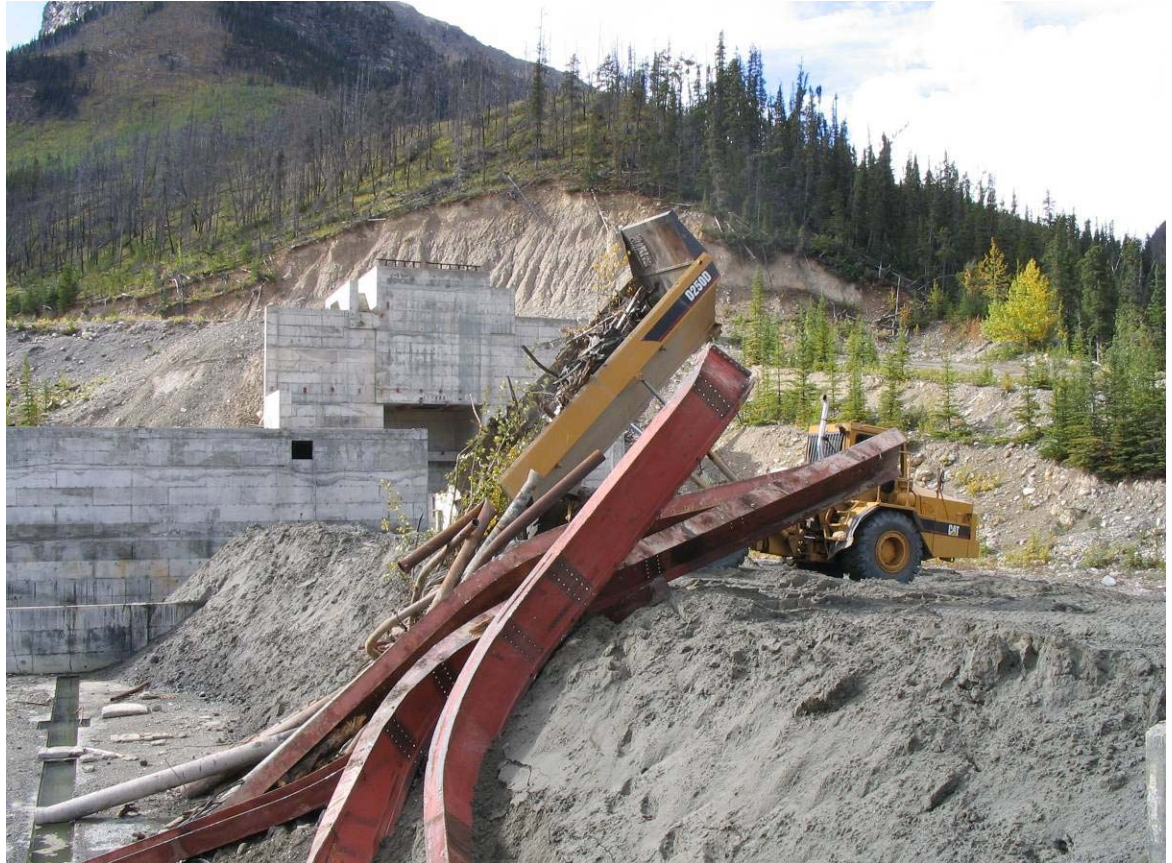
**34 - Filling Mill Site Landfill**

Steel and refuse were placed in this landfill such as the beams from the Mill Site Bridge, steel pipe found in the creek flowing to the north of the site and electrical transmission cable (photo 34). In addition, the landfill near the shore of the Racing River was excavated and placed in this landfill.

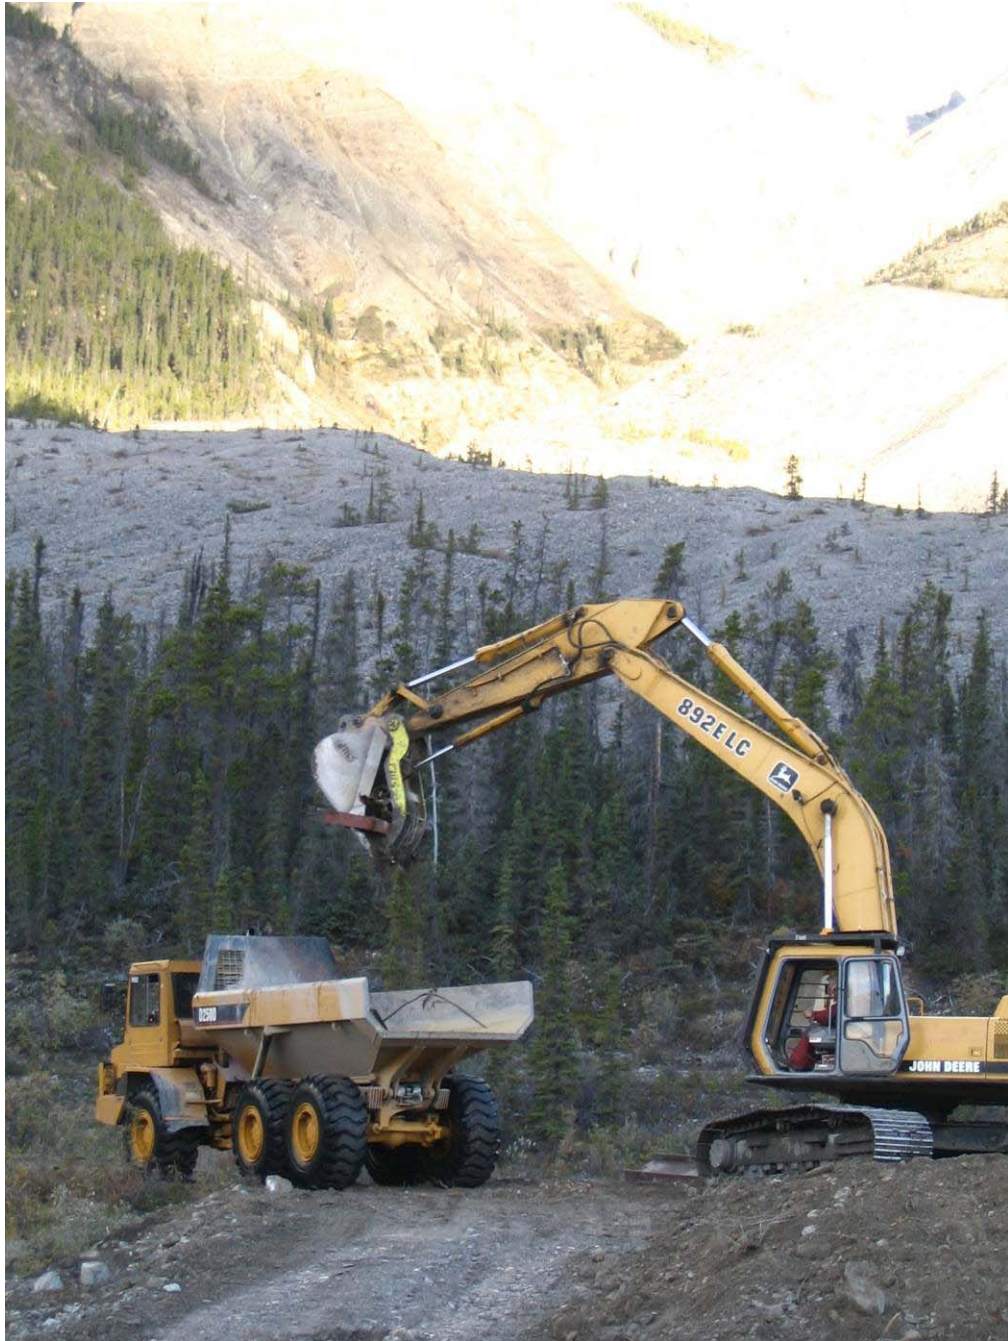
### **35 - Cleaning up Wokkash Corridor Road**

Exposed metal culverts and steel refuse was gathered from the access road as the equipment was moving from the site (photo 35).

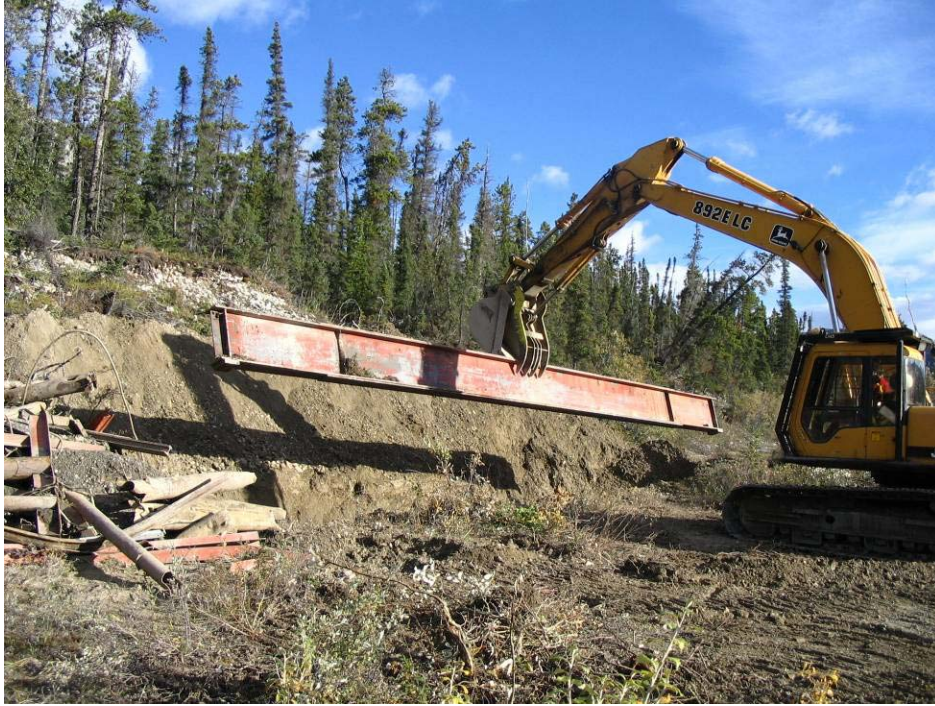
**36 – Filling Racing River Landfill**

A third landfill was established near the Racing River above the flood plain. All road cleanup material and the metal and wood from the bridge were deposited in at this site (photos 36 and 37).

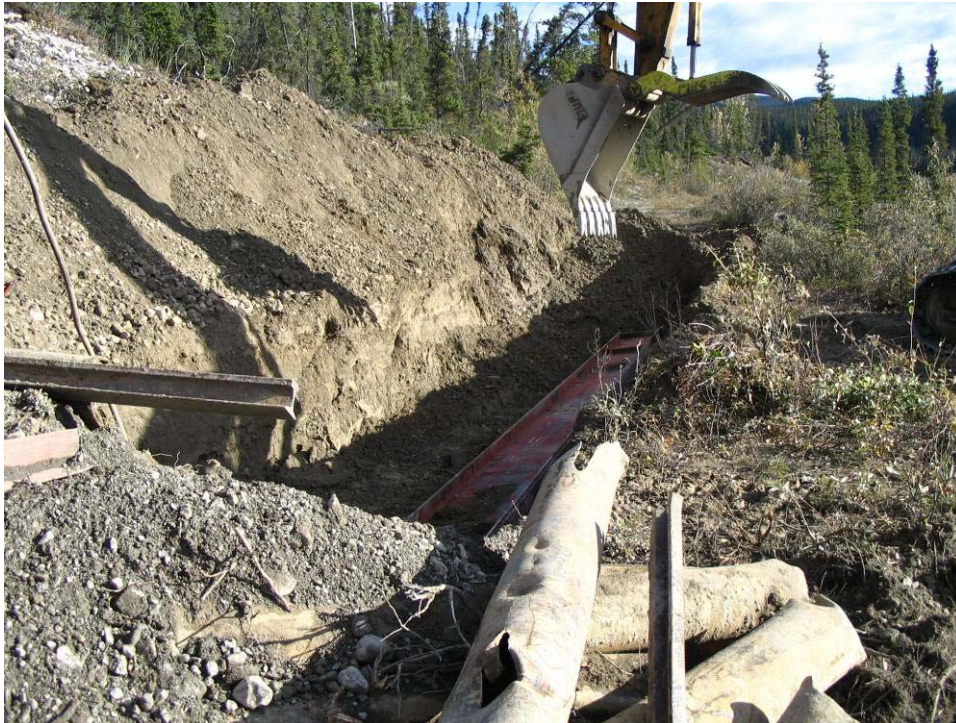
**37 – Racing River Landfill**

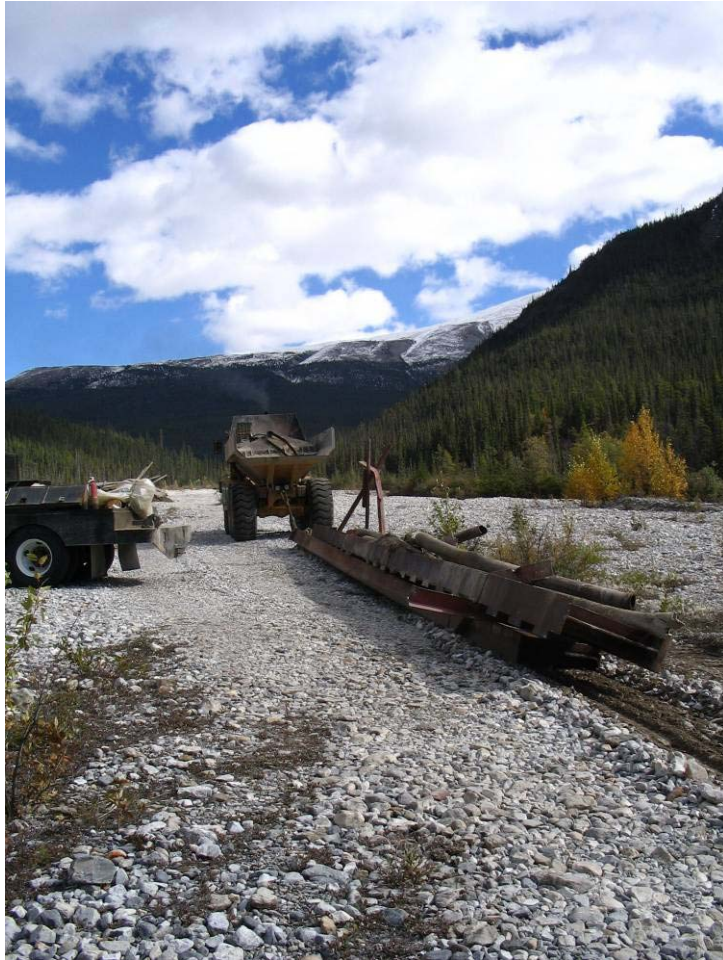
**38 - Hauling Steel To Landfill Above Racing River Flood Plain**

A fourth smaller landfill was developed on the east side of the Racing River. This site was established to allow burial of steel from the bridge without having to drag the steel through the river (photo 38).
