# HALFWAY RIVERTRAIL FEASBLUY STUDY

February 15, 2019

#### Halfway River Trail Feasibility Study

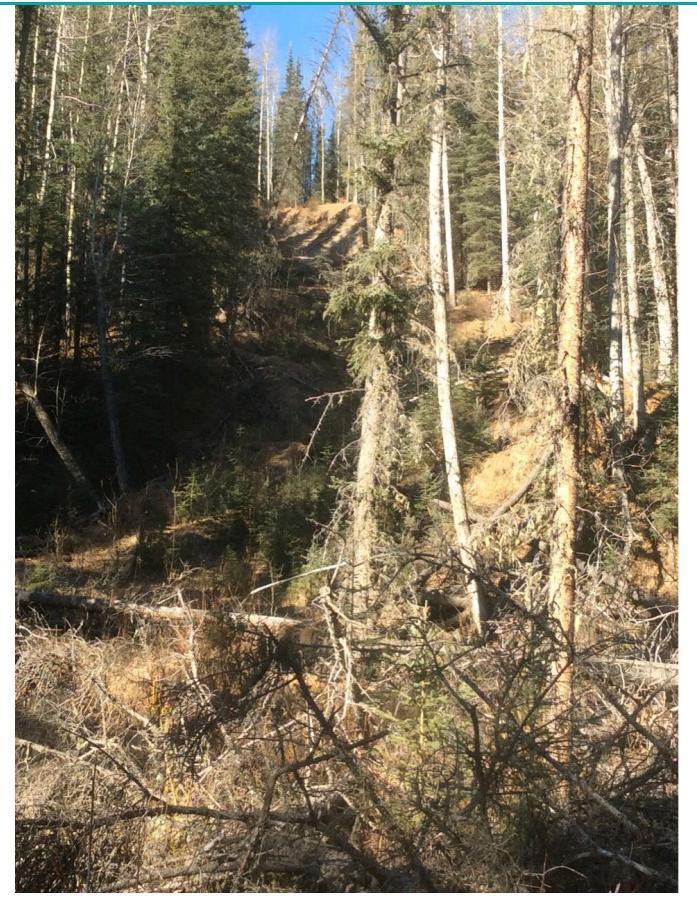
South West Option Ascent of North Bank of Halfway River 1

Ascending the North bank (south facing) the landscape is slightly drier probably due to the aspect. However, the soil still shows signs of frequent small slumps, with one landslide having run roughly 30 of the 40 vertical meters down the hillside (shown to the right). This hillside is very steep, and it is not anticipated that a 1.8m wide trail bench cut would last over the long term due to natural or human caused slumps.

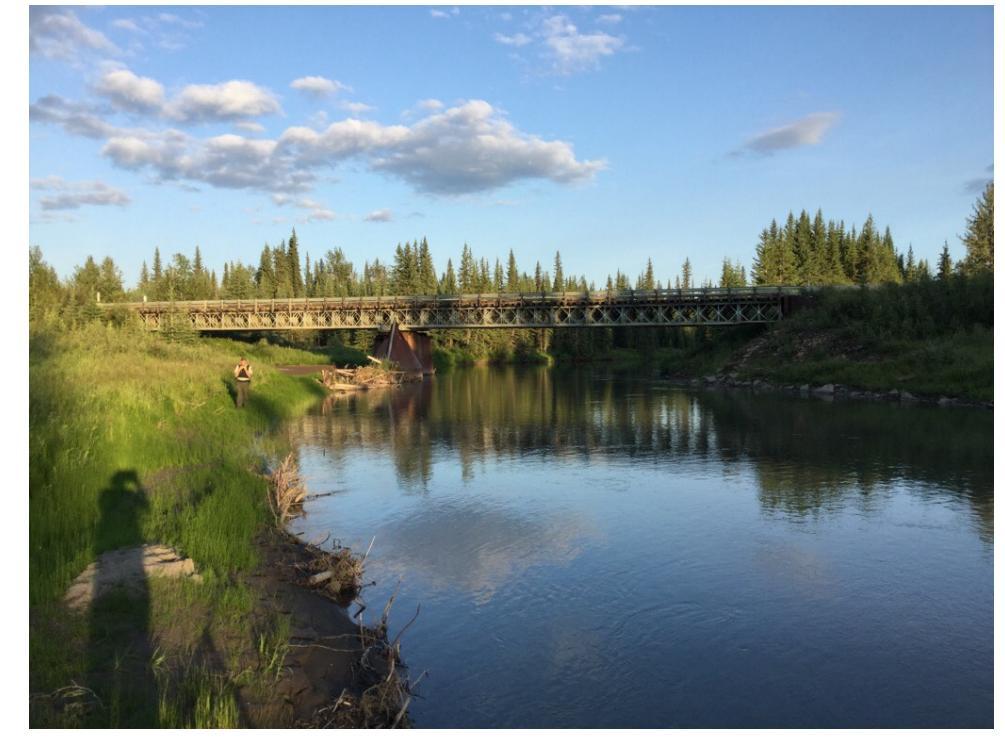
Figure 7 Bridge over the Halfway River on the Cypress Creek Rd

trails technologists believe that given the width of the river, it's shifting nature, gravel base and silt banks, and the signs of flood debris, a highway style bridge, similar to the bridge on the Cypress Creek Road (see Figure 7), is the likely crossing structure that would be required. Further study by a bridge engineer and geotechnical engineer is required if the consulting team recommendation to avoid the Southern Route Option is not accepted.

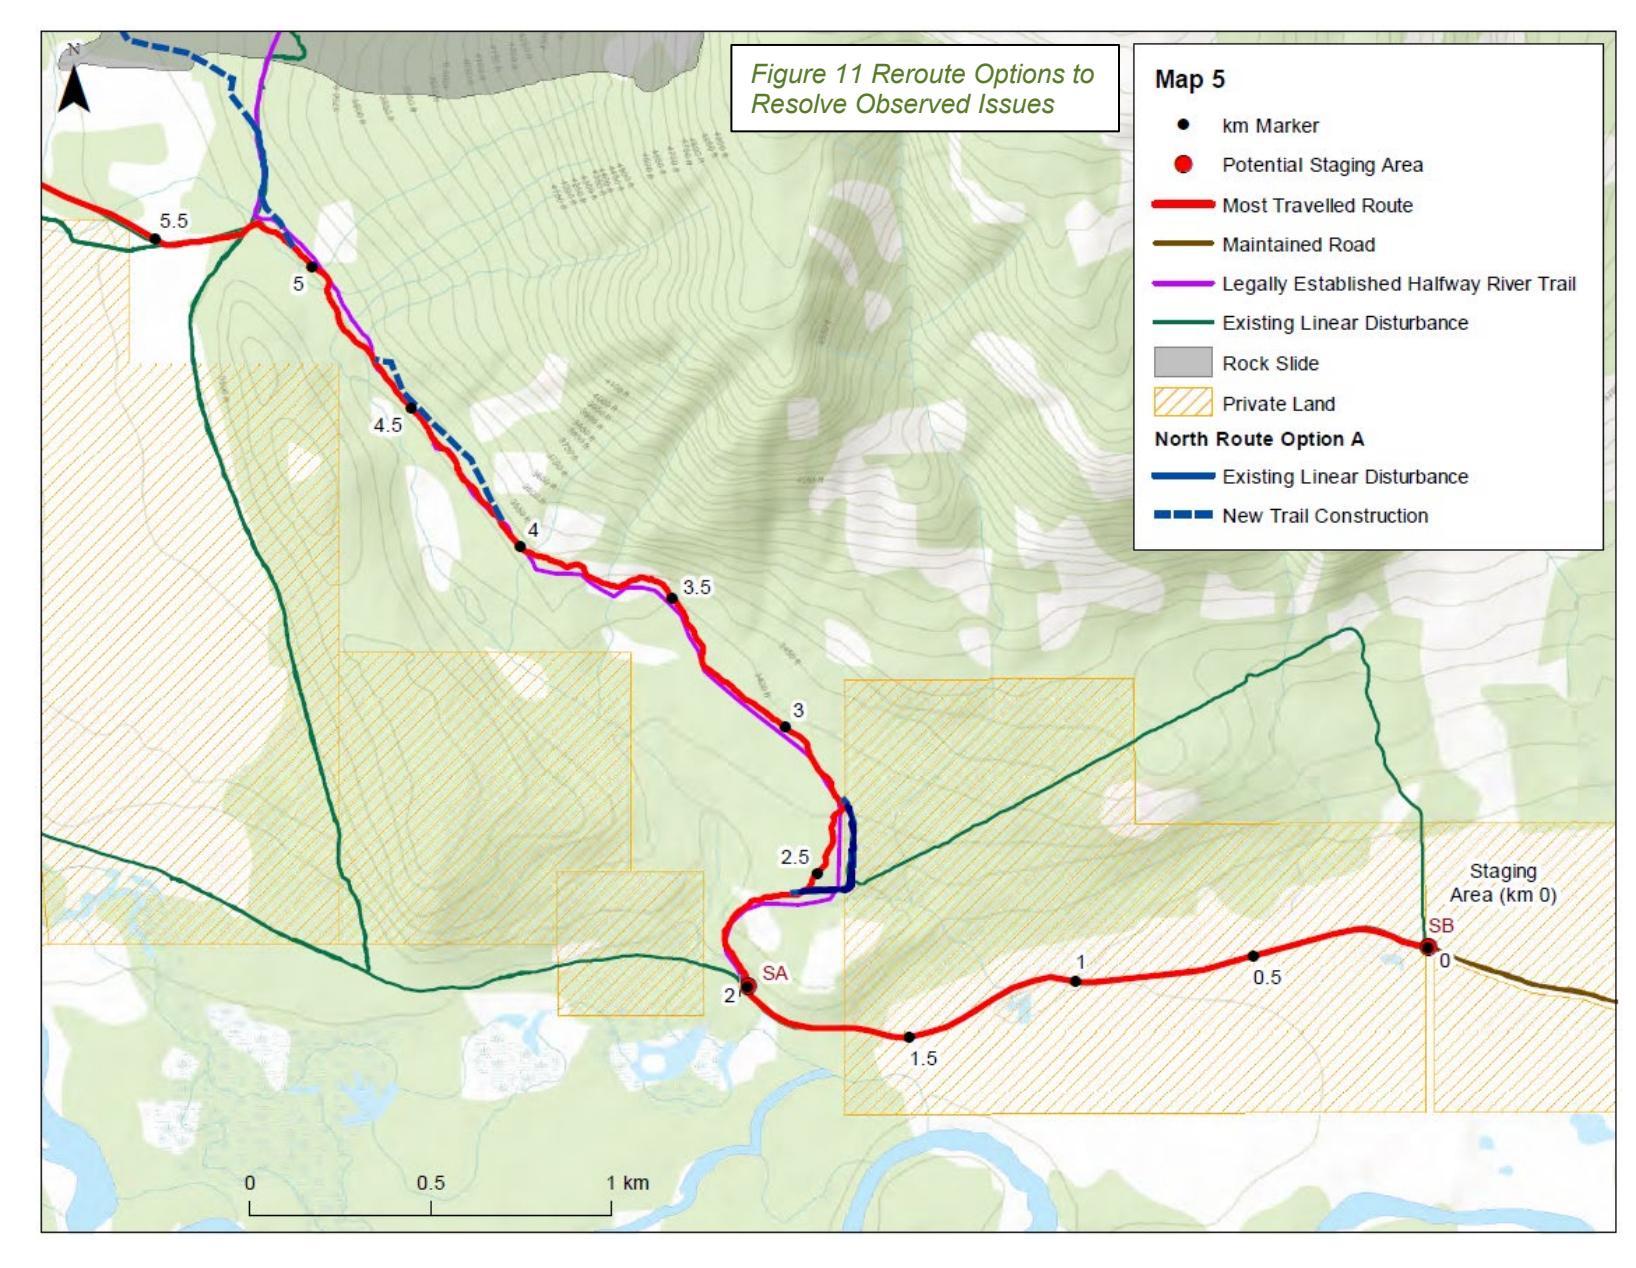
## 4.3.1. Segment on the Southern Slopes of Pink Mountain (Eastern Segment) (Km 2 – 2.8)

rail Condition Passable

**Defect Summary:** Current trail is passable however there are numerous sections where it is built in the flat area and holds water and has developed ruts. There is a bottom to these ruts, so users are still able to travel though this area however some trail widening, or braiding is already occurring to avoid the wet areas. Note, the Legally Established Halfway River Trail near km 2.5 is just a line drawn on a map, users currently travel east of it though the wet area or west of it in the private land.

Recommendations:		Realign existing trail where needed using Option A and confine and harden wet areas (Figure 11)		
Option A	<ul> <li><u>Description</u>: Realign km 2.4 – 2.8 onto the private land if possible. The route to the west is through a flat wet area.</li> <li><u>Pros:</u> <ul> <li>This existing route follows the contour to take the trail onto a small hillside where proper drainage can be established vs short cutting though the flat wet area.</li> </ul> </li> </ul>		Length (m)	Class D Cost Estimate
	<u>Con</u>	s: Involves land owner discussions and agreements.	890	\$3,600
Option B	Dese Pros Cons	<ul> <li>Cription: Repair existing alignment with raised trail tread and ditching.</li> <li>Avoids land owner discussions.</li> <li>Crosses a flat wet area which will require significant construction to create a dry and sustainable trail tread.</li> </ul>	800	\$32,000

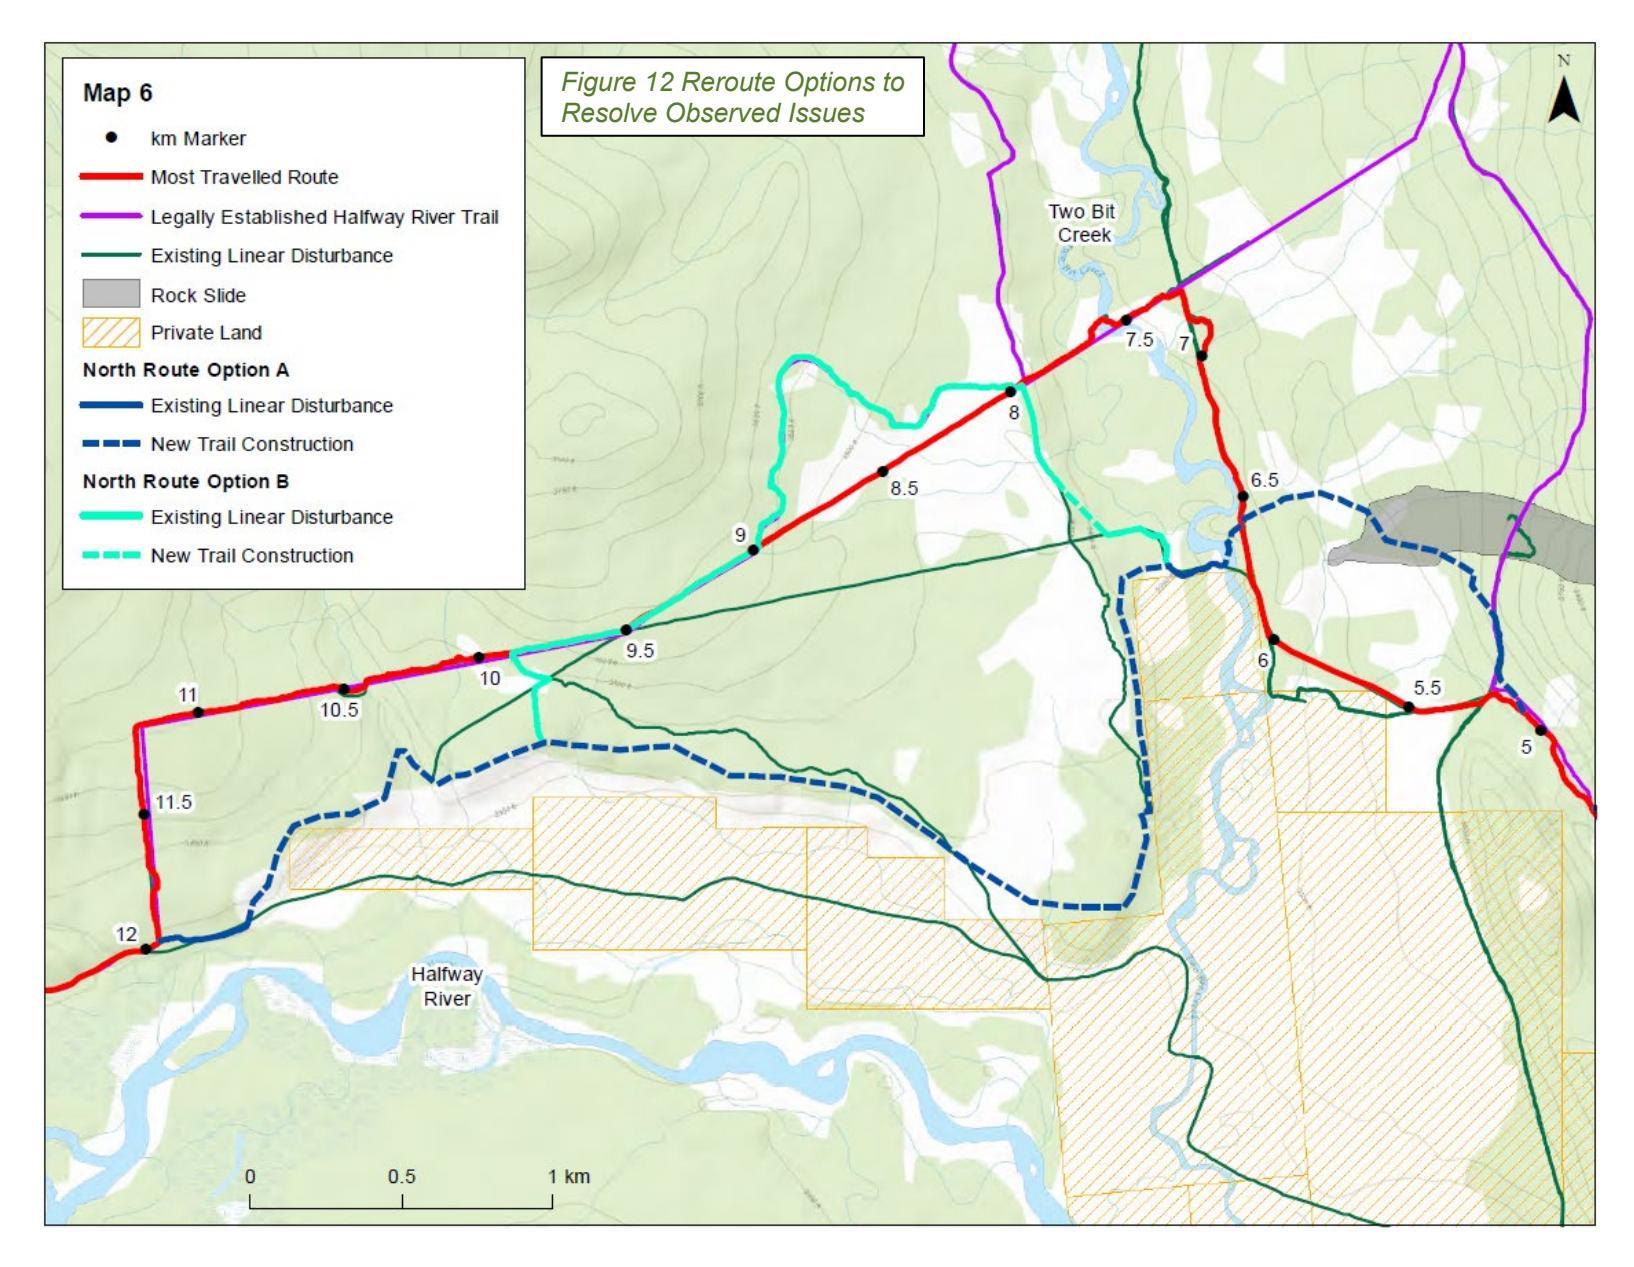
## 4.3.3. Approach to Two Bit Creek (Km 5.3 - 6.5)

Segment	Km 5.3 – 6.4	
Trail Condition	Bottomless Muskeg	Approach to Two Bit Creek

**Defect Summary:** Current trail alignment follows old cut lines that never had any ground work. Part of the segment is a series of mud holes and is very widely braided and shows signs of users frequently becoming stuck. Note, the Legally Established Halfway River Trail that travels north shows next to no use.

Recommendations: Realign existing trail using Option A, partially on existing road and construct new trail as necessary (Figure 12)			Cost Estimate
	<ul> <li>Description: From km 5.3 head north on a fairly well-built road. When the grades make sense construct a new trail as a bench cut with sidehill drainage out onto the debris from the rock slide off Pink Mountain. Use this debris material with a high rock content and some fines as the trail tread as opposed to the nearby muskeg. There may still be a segment of muskeg to cross or a small drainage that will need proper trail construction. The final approach to Two Bit Creek can follow a series of ridges to stay high and dry.</li> <li>Pros:         <ul> <li>This will avoid the need for costly raised tread for 500m on the current alignment</li> <li>Final product will provide reduced maintenance due to removing fall line and extensive raised tread.</li> <li>Avoids private property.</li> </ul> </li> </ul>

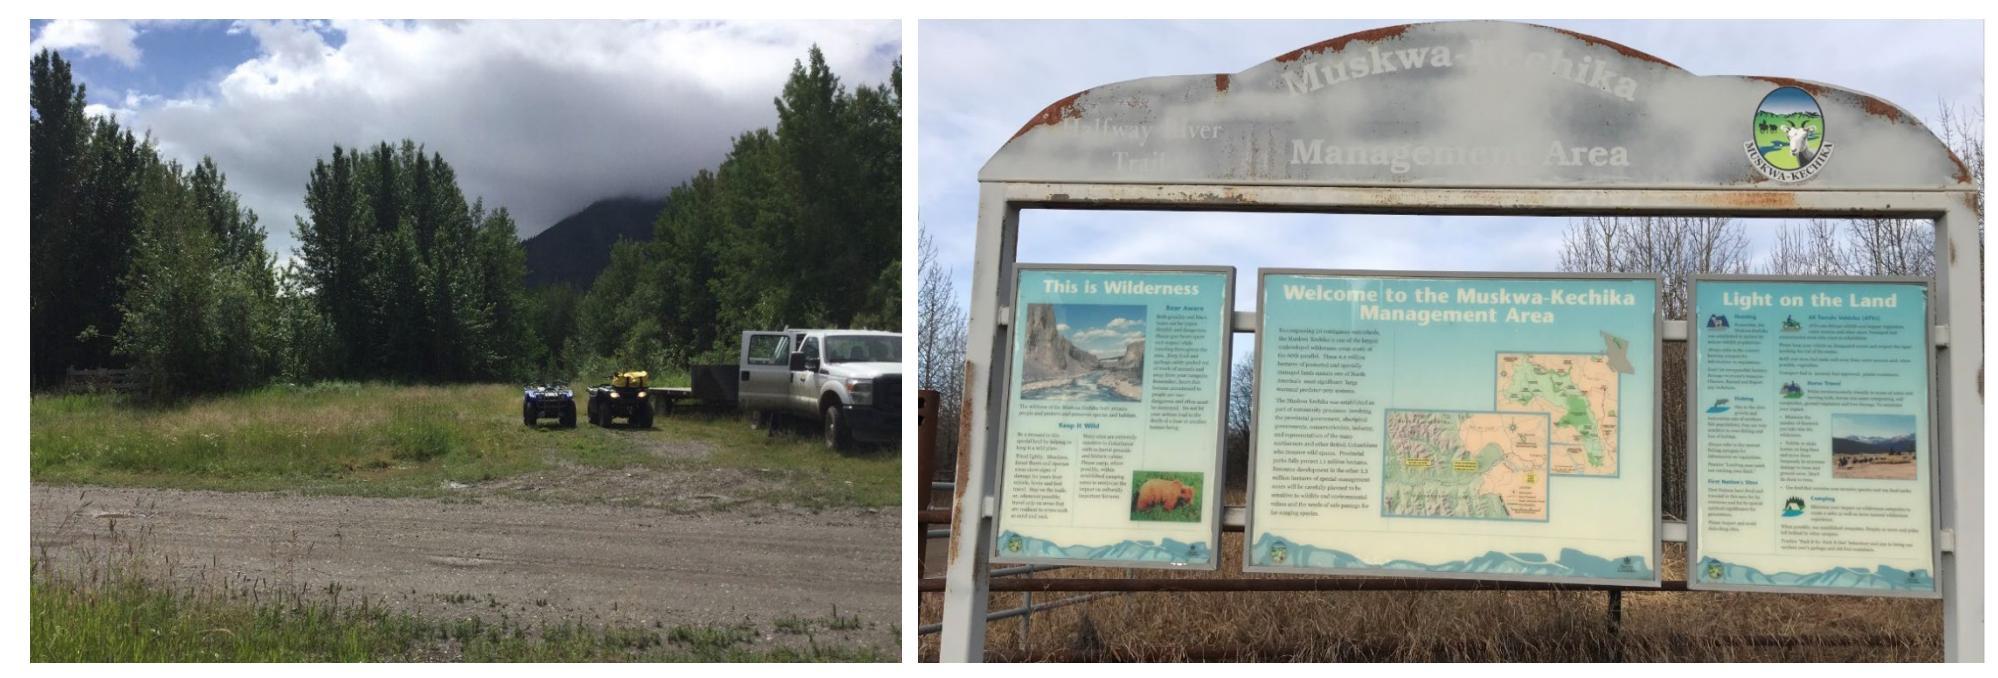
Figure 14 Current informal trailhead site.

**Staging Area SB** is the second option for staging on the North Route. It is at the existing informal staging area at km 0 of Halfway River Trail (see Figure 4). This site is located outside of the current gate and has a strip of public land to accommodate summer and winter users. Data available to the consultant team did not identify any major environmental constraints or land tenure constraints. However, the area is within private land, as such, consultation with the landowner will be essential to ensure support for and appropriate design of the Staging Area. The informal staging areas contains some signage which is in poor condition and almost illegible.

The area has desirable development characteristics as it is a large, relatively flat area, with minimal trees or mature vegetation, easy access and egress from the road and good sightlines along the road. This site is less desirable than SA due to the extra distance to be travelled along the Pink Mountain Road by ORV or Horse, the narrower strip of crown land, and the lack of water nearby.

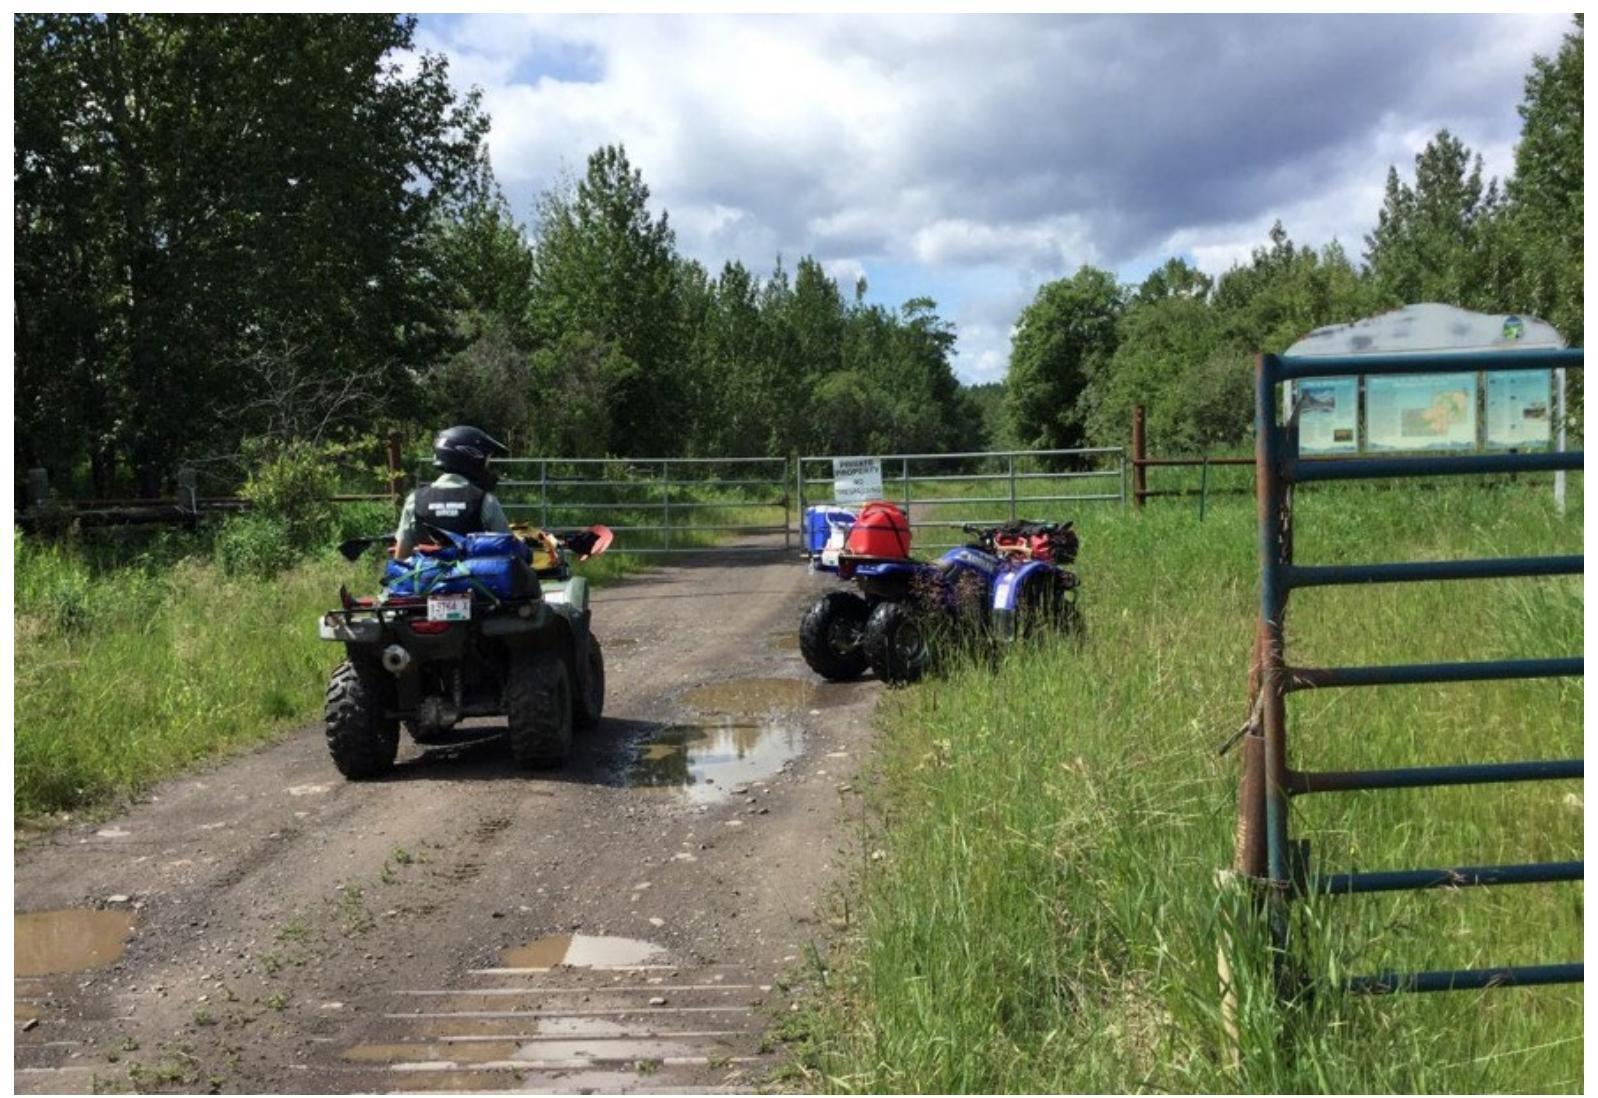
Figure 16 Trailhead sign and closed gate with no trespassing sign at the start of the current and proposed trail alignment.

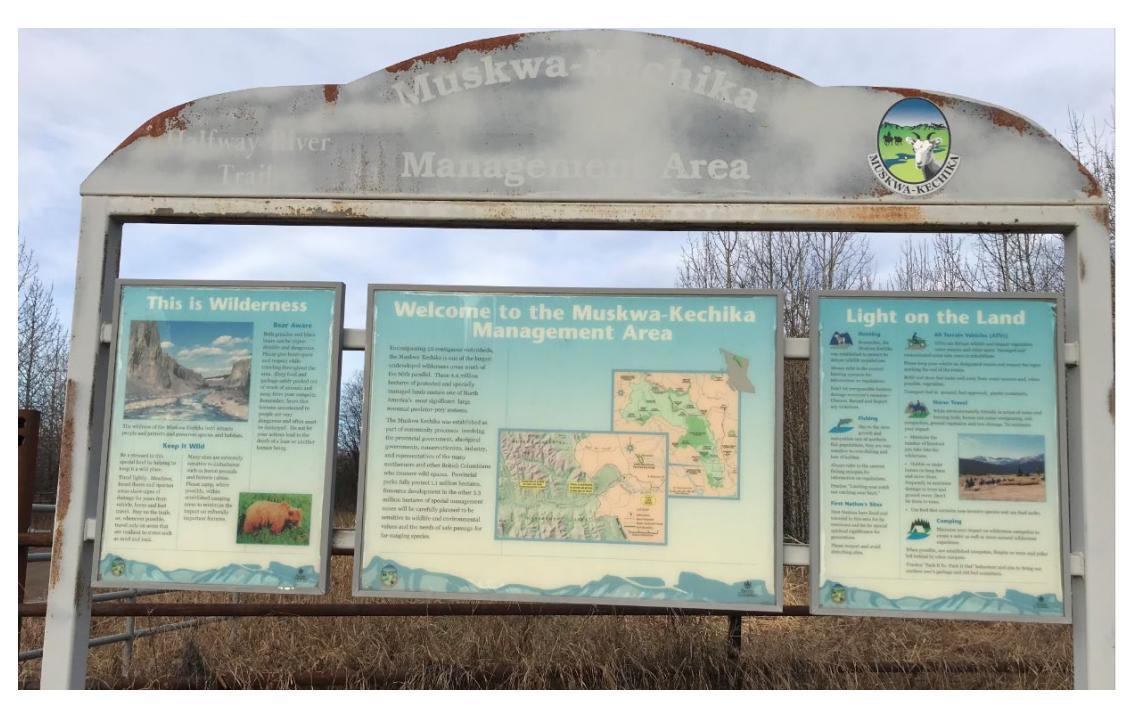
Figure 18 Existing trailhead sign

Only one official sign was observed on the existing Halfway River Trail. As shown in Figure 18, the sign is a trail head sign and is in poor condition. The sign contains basic wayfinding, responsible use and interpretive information.

- o Interpretive signage could be established to help increase seat time, enhance the visitor experience and improve responsible use.
- Update the trailhead signage to ensure it includes essential visitor information taken from the Trail Management Objective. This information will help users prepare for the trail conditions, be prepared while also helping to manage risk to RSTBC.
