**Overview Fish and Fish Habitat Inventory
Muskwa-Kechika Management Area**

**Muskwa West Pre-Tenure Plan Area
and
Buckinghorse & Pocketknife Portion of
Besa-Prophet Pre-Tenure Plan Area**

Joseph S. De Gisi
Box 2518
Smithers, BC
V0J 2N0

31 March 2002

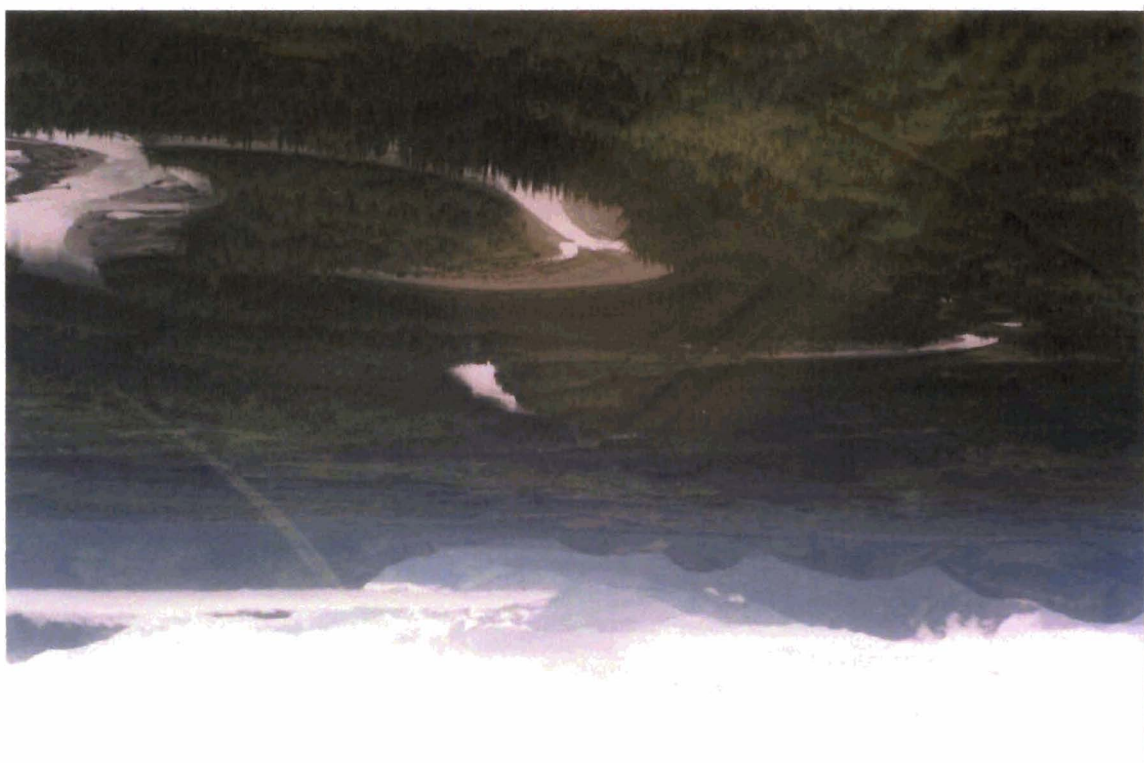
Photo 1. Muskwa River valley (upstream), near Puder Creek mouth.
Roll 4, Frame 4. CD #2, Image #0404.

transported sediment. The deposition causes the channel to meander tortuously and form numerous large side channels and oxbow lakes in its floodplain (Photo 1). As the river assumes a north-northwestward course forming the eastern boundary of the Muskwa West PTPA, its channel gradually becomes more confined downstream, though still meandering moderately (Photo 2). In many places, meanders carry the flow against high eroding banks (Photo 3), so that during periods of higher discharge the turbidity downstream becomes more dominated by darker fines. At the north end of the Muskwa West PTPA, the Muskwa River channel is moderately incised (Photo 4) and the tributary streams from both east and west have downcut significant canyons to the floor of the Muskwa valley.

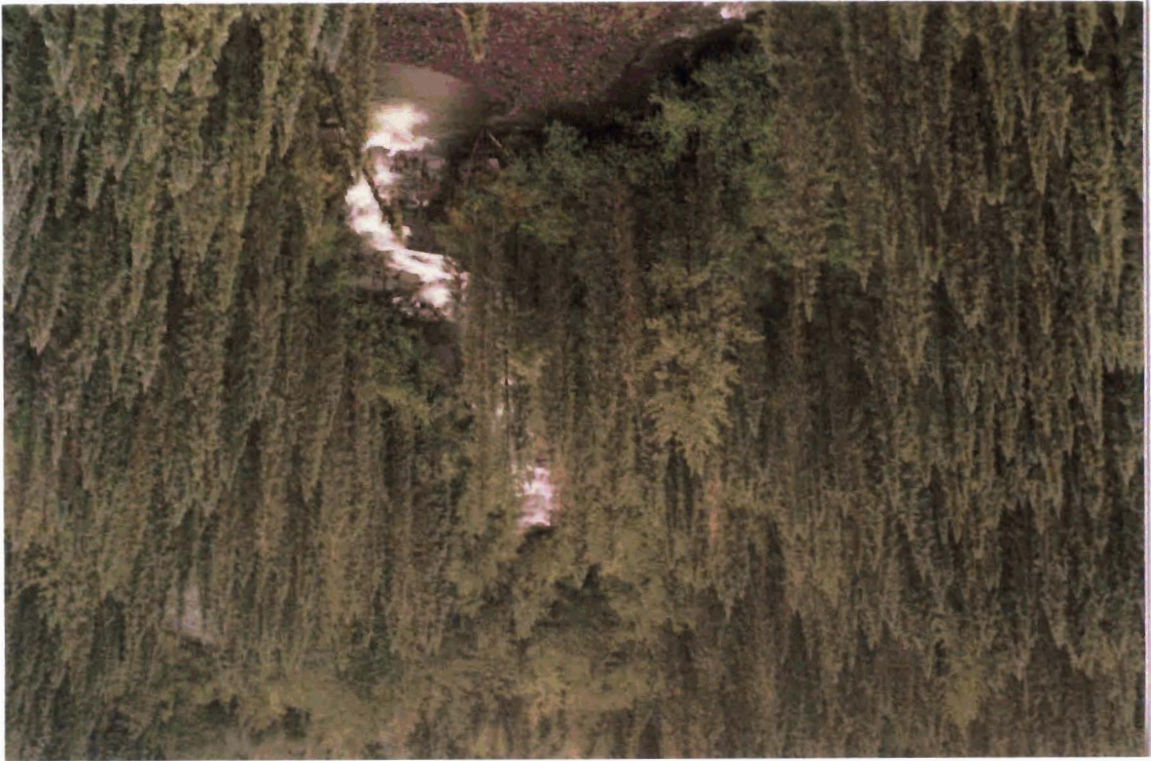
Photo 6. Cascades on unnamed channel 580800-30200-37400.
Roll 2 Frame 4. CD #1, Image #0204.

A single set of cascades on unnamed channel 580800-30200-37400, downstream of Muskwa West PTPA, comprised the only permanent impediment to fish passage noted during the field portion of this overview inventory (Map 2). Presence of a single fish, likely an adult Arctic grayling, was detected by electrofishing at site #1 on this channel upstream of the cascades. The occurrence of fish at the site suggests that the cascades are not completely impassable, as a headwater-resident population of either Arctic grayling or bull trout does not seem likely in this basin. Impassable permanent barriers to upstream movement of fish were not noted on any of the other channels within the UMUS portion of Muskwa West PTPA which were examined by the prior inventory activity in that group (T. Euchner, personal communication). During overflight in the 1998 inventory of MMUS (Burrows 2002), cascades judged impassable to fish were documented on the Chischa River channel within the Muskwa West PTPA (Map 2). That study noted no other permanent barriers on channels within the MMUS portion of Muskwa West PTPA, though cascades on Chlotapecta Creek were noted just upstream of the PTPA boundary and beaver activity was extensive on some streams.

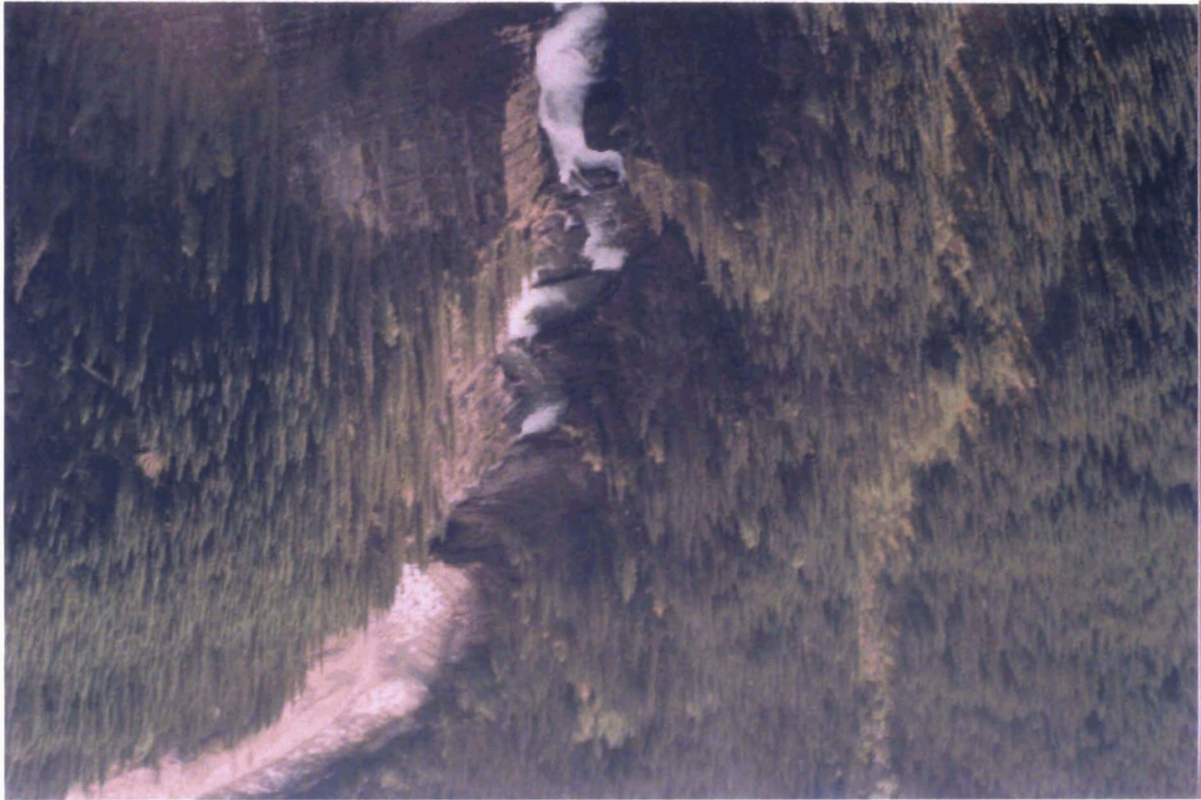
Photo 7. Cascades at upper end of lower Chischa River canyon.
Roll TB4 Frame 12 (Burrows 2002).

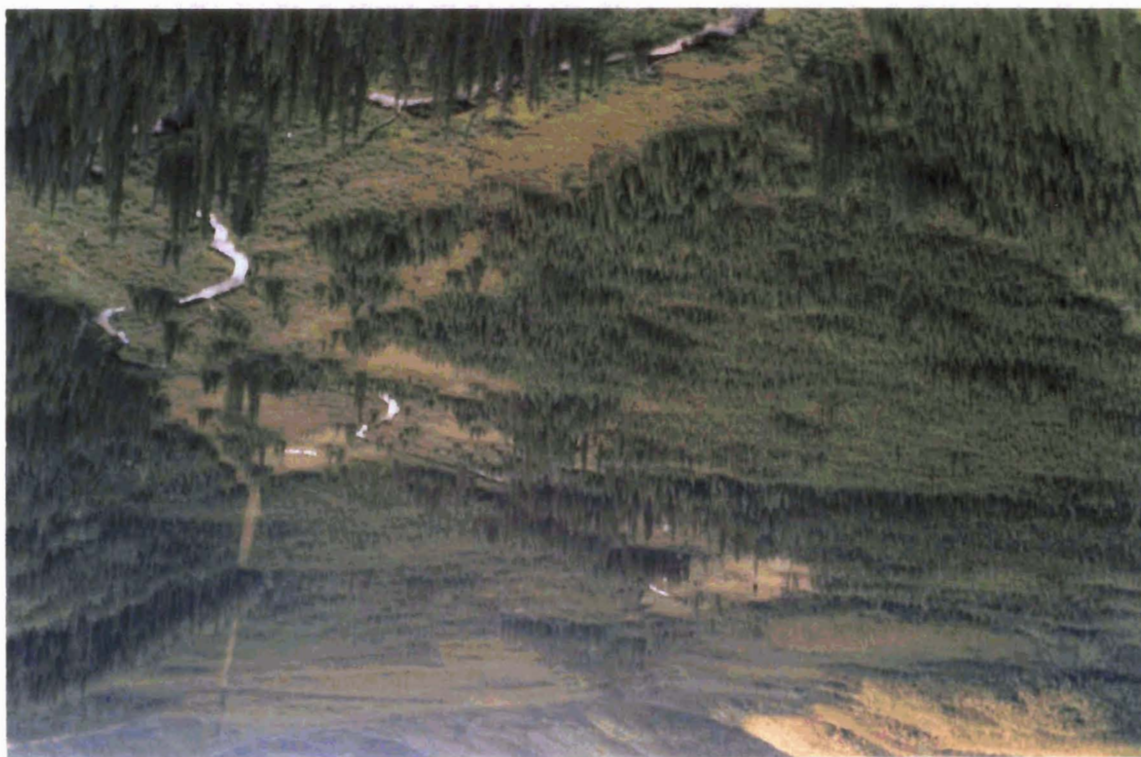
Photo 9. Unnamed channel 580800-43000 in vicinity of site # 7.
Roll 5 Frame 22. CD #2, Image #0522.

Unnamed channel 580800-43000 traverses the northern end of the southern portion of PTPA. The stream originates in the Rocky Mountain foothills west of the PTPA and south of the Tuchodi River. No fish were captured at the site, despite electrofishing a large quantity of good habitat. A low to moderate amount of beaver activity was present on the channel downstream of the site; failing daylight prevented a closer examination of the probability of fish passage.

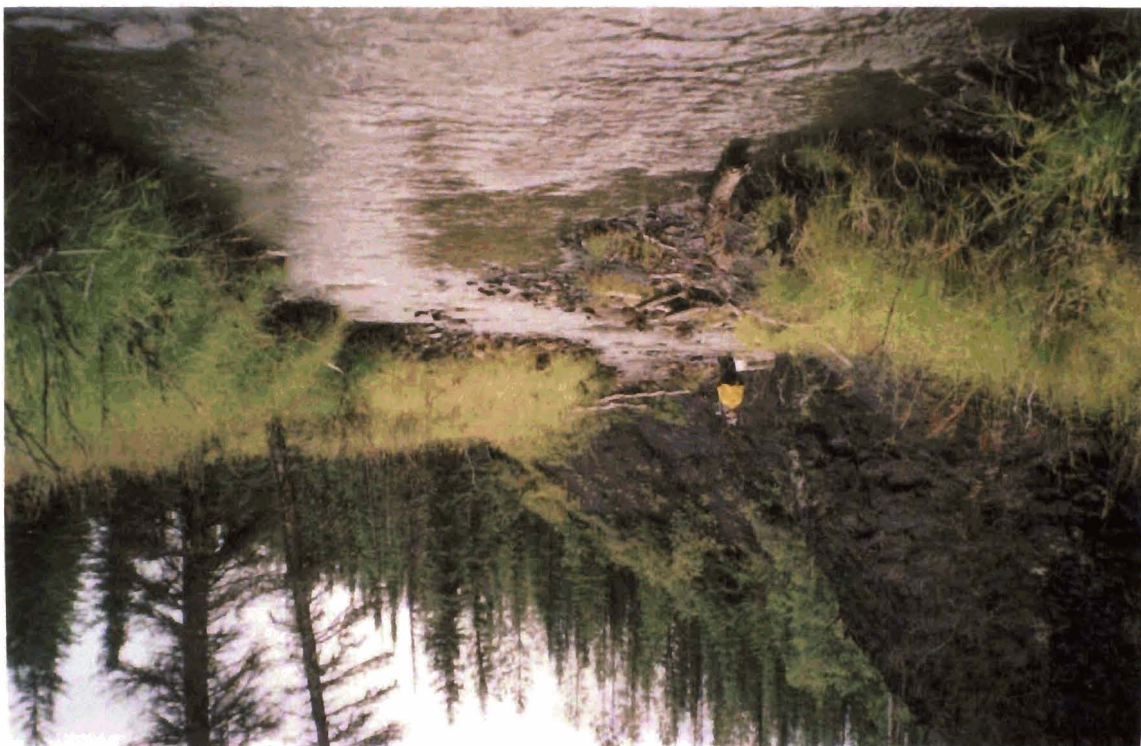
Photo 24. Upstream view in Site #4 on unnamed channel 580800-39100-39300, from breached beaver dam. Roll 1 Frame 24. CD#1, Image 0124.
