**RECONNAISSANCE LAKE
INVENTORY
OF SKEEZER LAKE**

Waterbody Identifier: 01158LIAR

EDI Project No. 704-01

March 2001

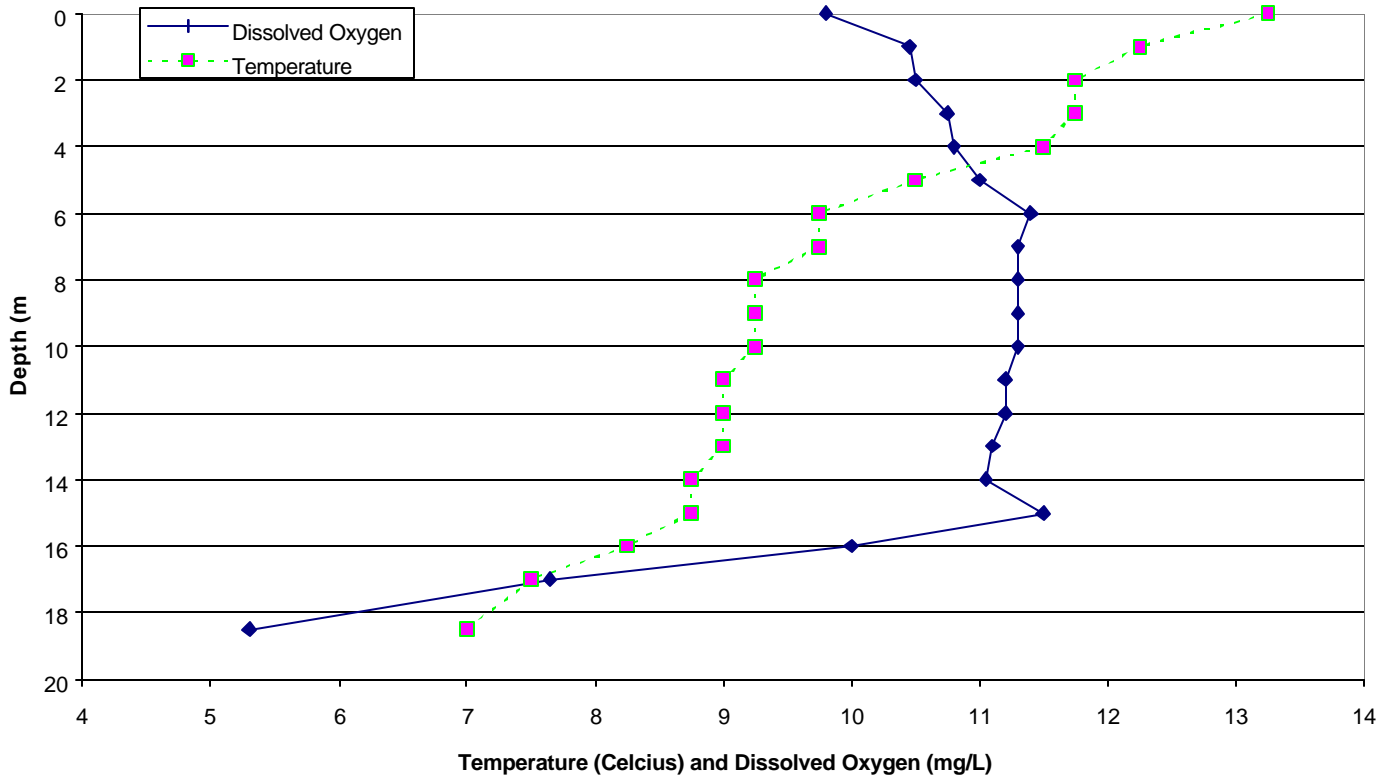
Figure 4.4 Dissolved Oxygen and Temperature Profiles of Skeezer Lake Taken on July 22, 2000.

The Secchi depth was 6 meters and the water colour was green at the time of survey. Dissolved oxygen levels ranged between 10.9 mg/L at the surface and 5.3 mg/L at the bottom. A pH of 7 was recorded at the water surface.

The lake was well oxygenated from the surface to a depth of approximately 15.0 m (Figure 4.4). Above this depth the dissolved oxygen levels were well above the recommended standard of 7 mg/L required for salmonids (CCME 1996). The dissolved oxygen levels rapidly decreased to 5 mg/L at depths below 15.0 m. The decline in dissolved oxygen is most likely a result of consumption of oxygen during bacterial decomposition of organic matter in the lake sediments (Wetzel 1983). As the volume of the lake below 15.0 m would comprise only a small portion of the lake, the dissolved oxygen profile suggests that fish could utilize the majority of the lake, if fish were present in this lake.

In northern temperate climates, lakes typically experience temperature stratification in the summer months as a result of daytime heating of the water column. The result is a distinct formation of a thermocline zone where temperature drops at least 1°C with each 1 m increase in depth (Cole 1994). A weak thermocline is present between 4 and 6 m depth (Figure 4.4). This lake most likely would not develop a strong thermocline due to a number of factors. These include a high latitude (above the 59° N parallel) and high elevation, the long axis of the lake is oriented in the direct of prevailing winds, and the majority of the lake was fairly shallow (i.e., < 10 m). The latter two conditions combine to create strong mixing conditions in lakes and would inhibit the formation of thermally stratified layers. A more prominent thermocline may develop later in the summer than the July 22 sampling date

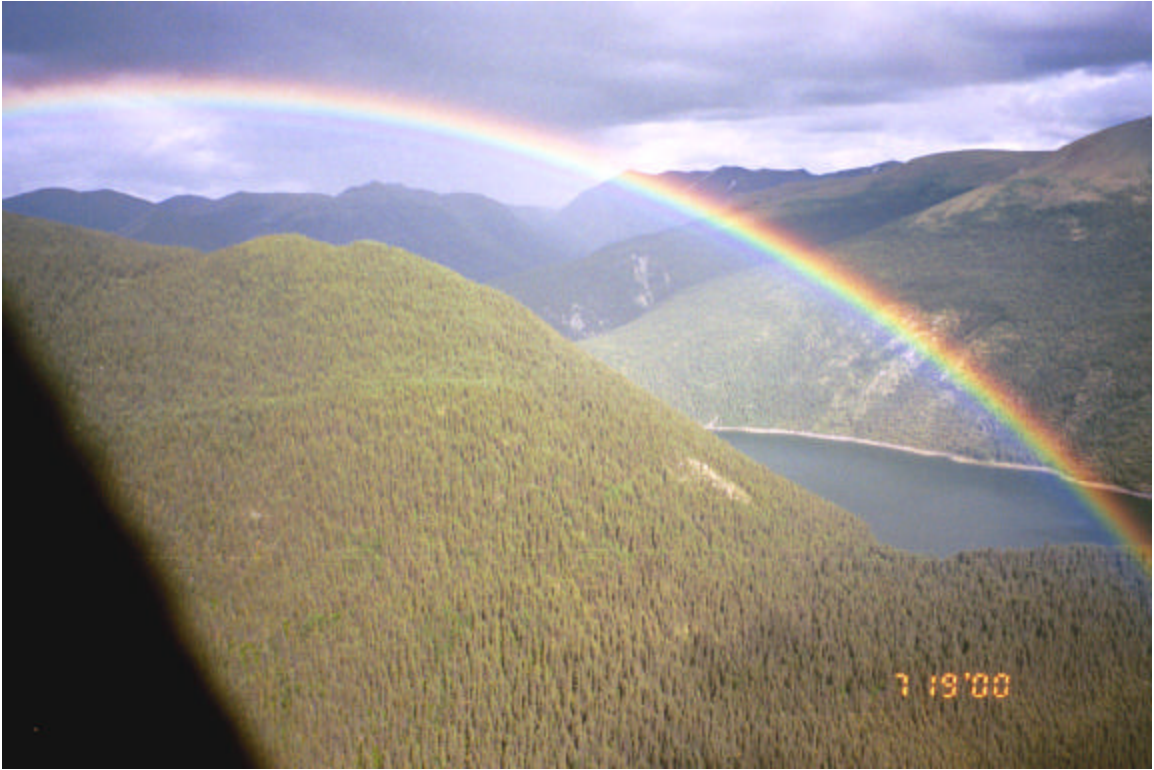
Roll 431, Frame 5. Watershed Code 210-547000-22600-82700-1560, Aerial view of west end of Skeezer Lake.

The lake had no surface outlet stream, although, there appears to be a subterranean outlet to this lake. At the west end of Skeezer Lake there is a ridge that blocks surface flow from leaving the lake; however, the stream immediately west of this ridge appears to form quickly into a large stream (3-5 m wide) as it cascades down the valley. It is suspected that the very large stream is probably fed from underground flows that probably originate in the very deep hole that was located in the western basin of the lake.
