# HALFWAY RIVERTRAIL FEASBLUY STUDY

February 15, 2019

#### Halfway River Trail Feasibility Study

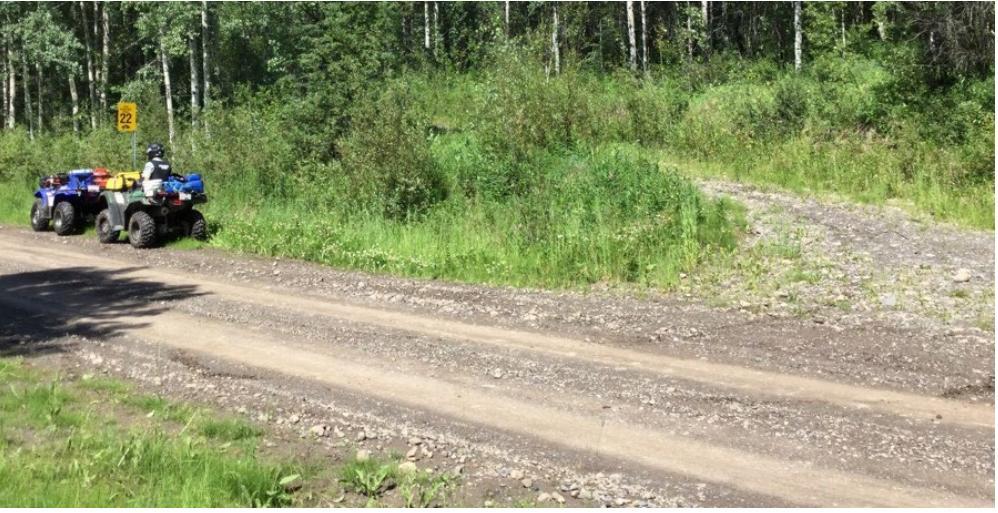
Figure 13 Potential Staging Area SA, located where users leave the graveled and graded Pink Mountain Road and head north onto smaller roads and trails.

**Staging Area SB** is the second option for staging on the North Route. It is at the existing informal staging area at km 0 of Halfway River Trail (see Figure 4). This site is located outside of the current gate and has a strip of public land to accommodate summer and winter users. Data available to the consultant team did not identify any major environmental constraints or land tenure constraints. However, the area is within private land, as such, consultation with the landowner will be essential to ensure support for and appropriate design of the Staging Area. The informal staging areas contains some signage which is in poor condition and almost illegible.

- Gravelled pad
- Angled parking for trucks with trailers
- Pull through access and egress to allow easy exit and entry onto the road for trucks with trailers
- Warming shelter for winter use (pending anticipated level of winter use)
- Pit Toilets (pending anticipated levels of use)
- Trailhead kiosk with wayfinding, regulatory, responsible use and interpretive signage
